**Tioga County Industrial Development Agency
July 10, 2019 • 4:30pm•
Ronald E. Dougherty County Office Building
56 Main Street, Owego, NY 13827
Agenda**

Huntington Creek Background Report

**Susquehanna Geomorphic Assessment
Huntington Creek**

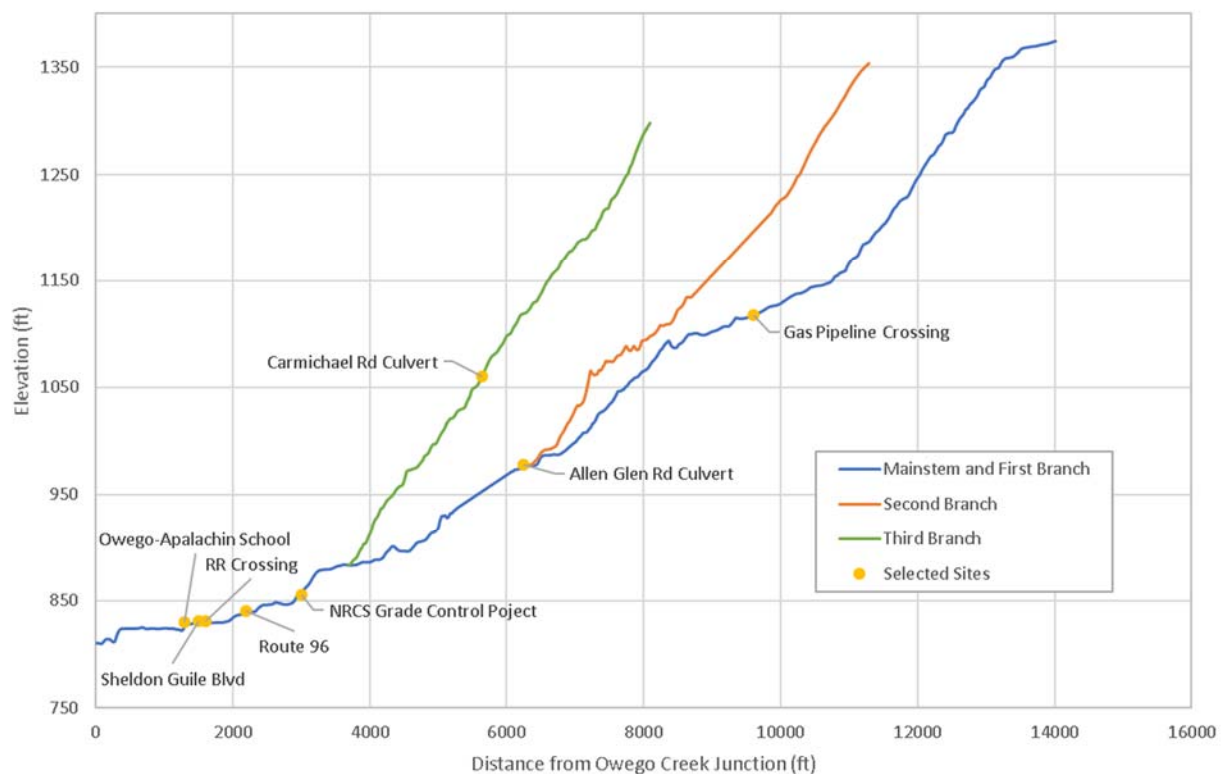
Figure 3. Longitudinal profile of Huntington Creek, including first, second, and third branches. Several locations discussed in this report are shown along the profiles for reference.

The Huntington Creek watershed can be broken into two broad regions: the steep uplands and the low-relief valley floor at the confluence with Owego Creek (Figure 3). The steep uplands, which include the three branches and the upper portion of the mainstem are characterized by steep and confined channels with small or nonexistent floodplains. Average slopes along the upland branches are on the order of 7 to 9% (Table 1), with higher slopes occurring locally and along smaller tributaries. The combination of high slope and confinement is capable of generating flood flows with sufficient velocity and depth to erode and transport the abundant sediment present in surficial deposits, as well as dislodge/abrade and transport the highly erodible bedrock.

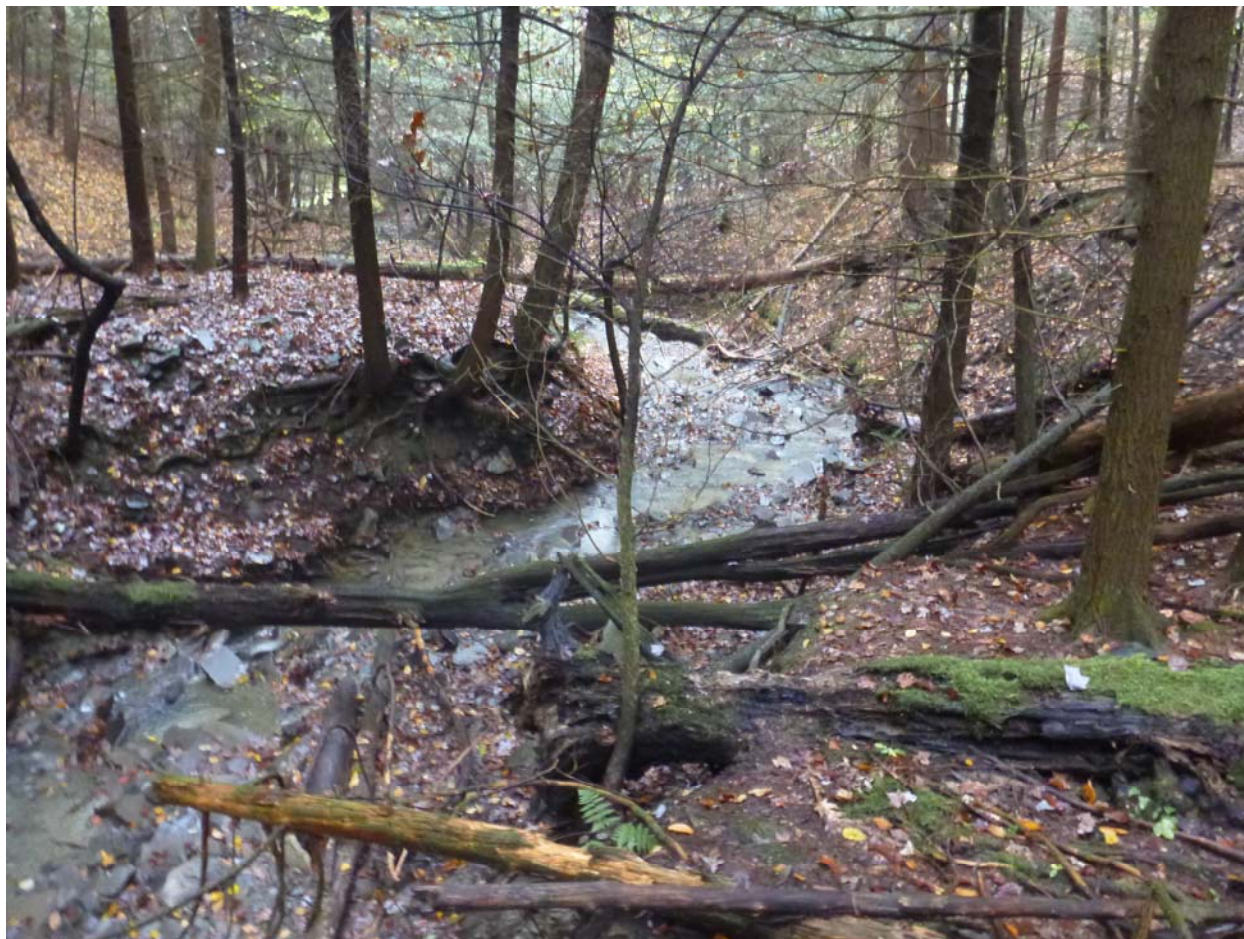
Figure 6. A representative reach of the second branch. Flow level indicators suggest that bankfull width and depth through this reach are approximately 15 feet and 2 feet, respectively. Slope is approximately 7%. The channel sits well below the floodplain.

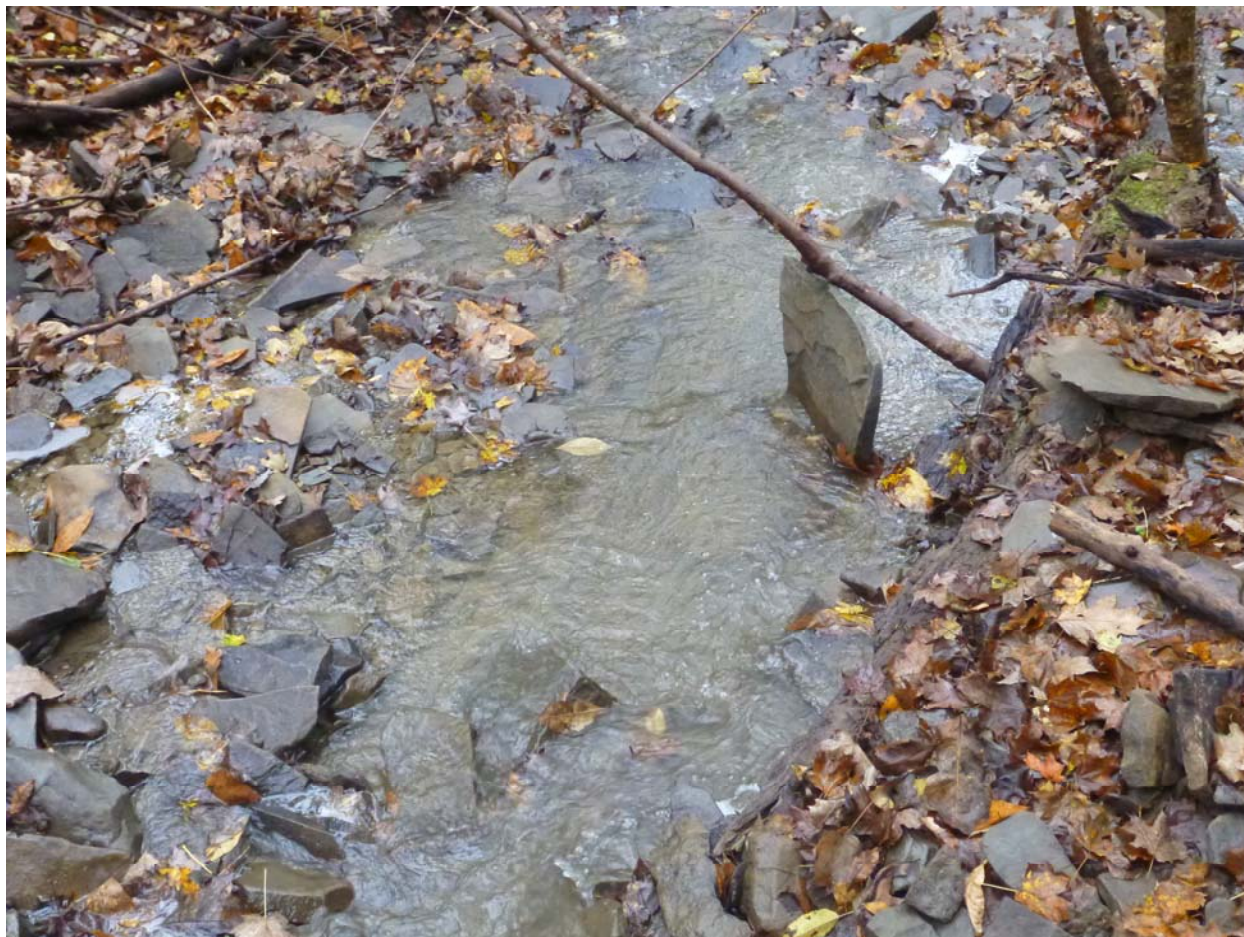
Figure 7. A clast greater than 1 foot in diameter (intermediate axis) that was recently mobilized in the first branch of Huntington Creek and pinned beneath a small piece of wood. Imbrication of the bed indicates that the bed material is generally mobile.

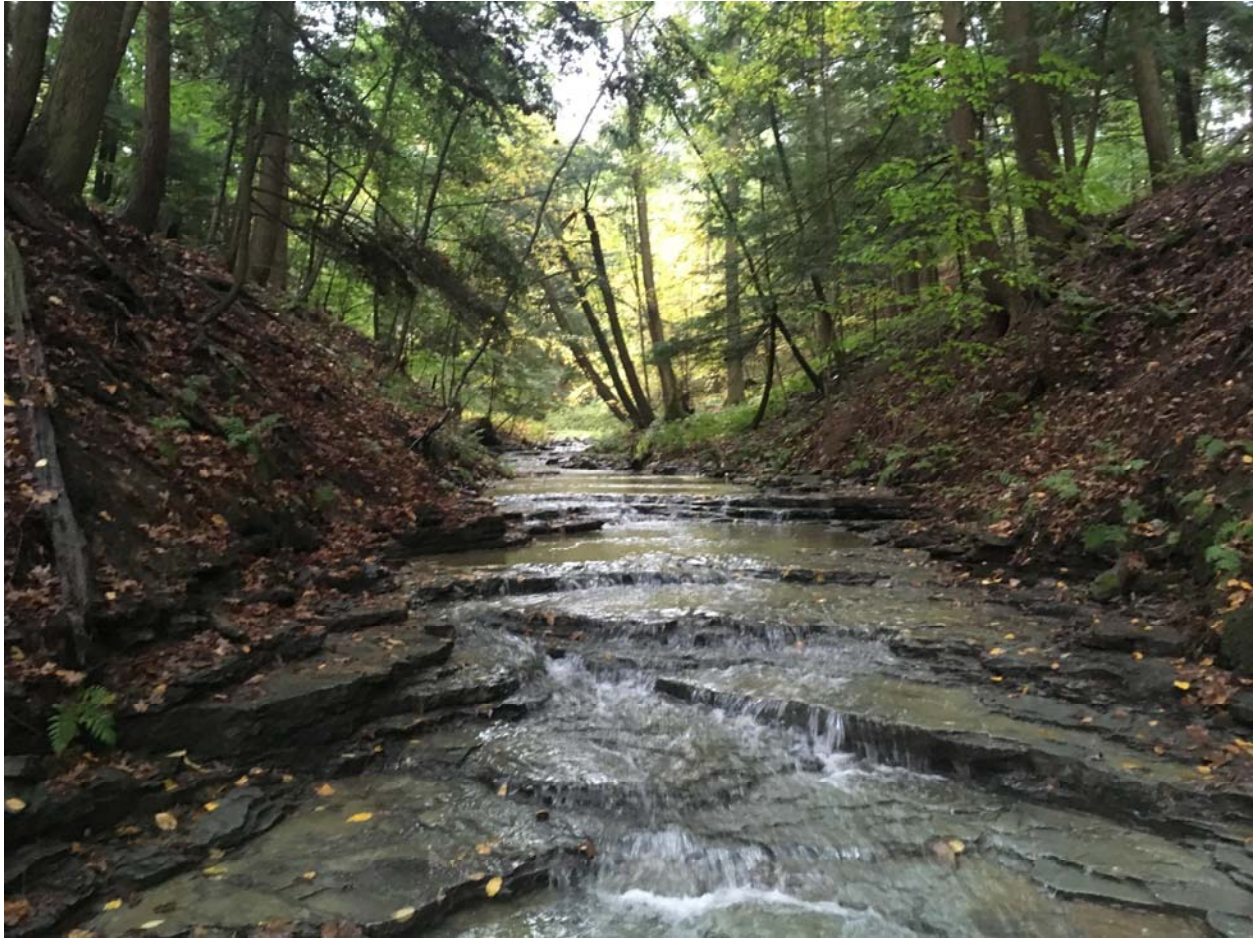
Figure 8. Looking upstream at a bedrock reach on the upper mainstem of Huntington Creek

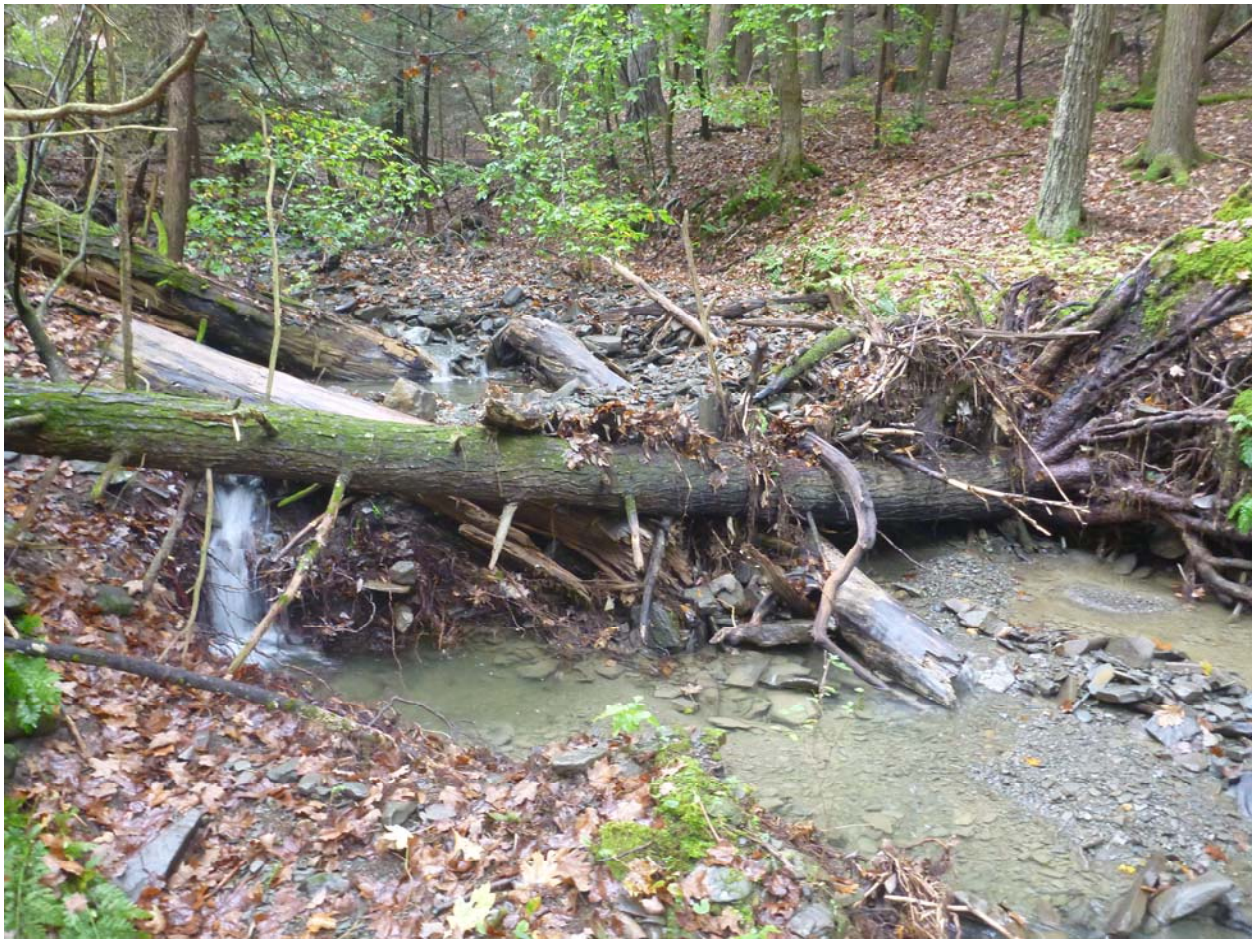
Figure 9. Rare example of a large woody debris jam in the channel along the second branch tributary to Huntington Creek. In this instance, a single channel-spanning piece of wood initiated a jam by trapping sediment and other woody debris. Approximately 200 cubic yards of sediment are retained as a result of this single structure. The difference in bed elevation across the jam is approximately 2.5 feet.

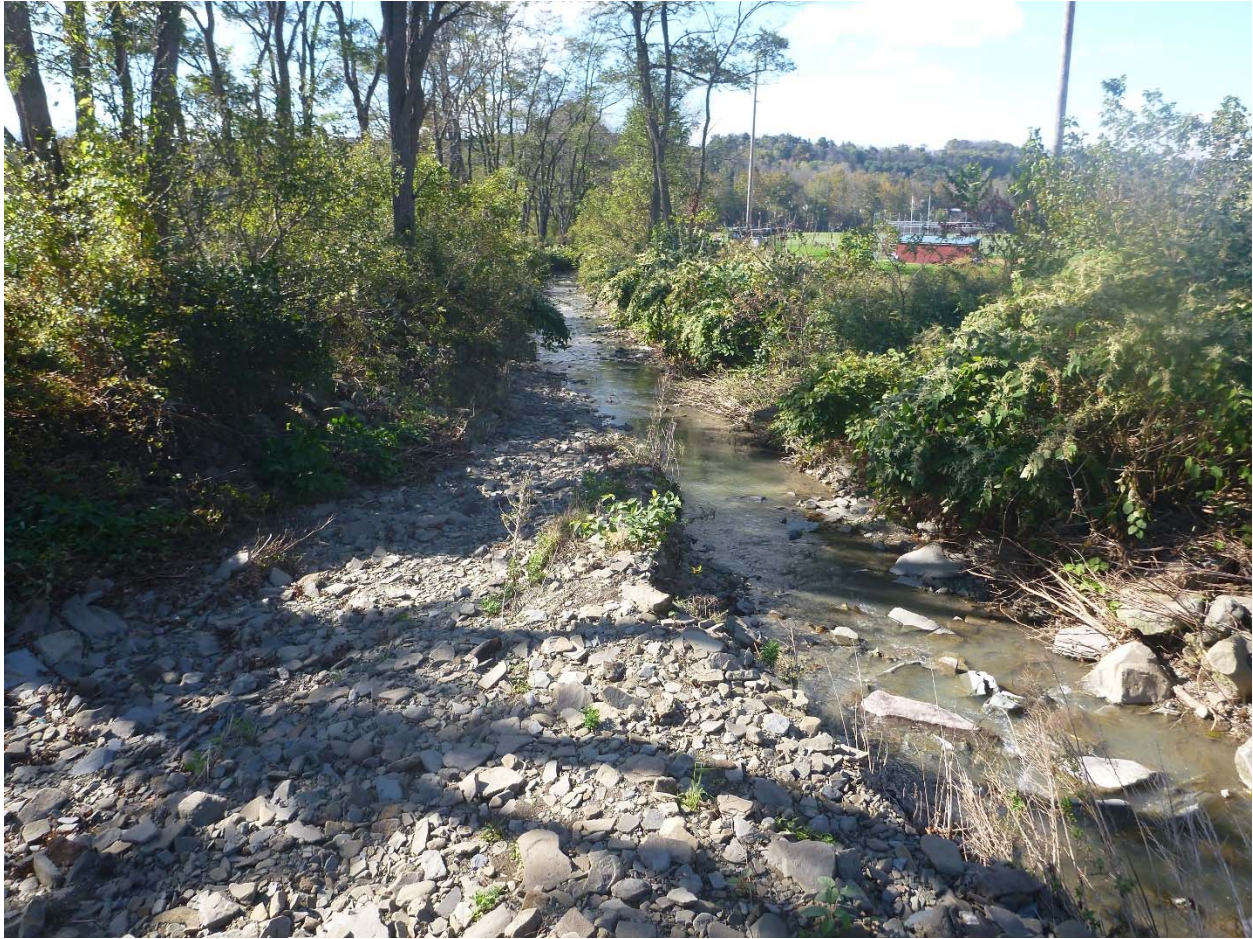
Figure 10. Looking downstream along mainstem of Huntington Creek as it flows toward Owego Creek across the Owego Creek floodplain (river station 1200). Through this reach, the bankfull width and depth are approximately 40 feet and 2.5 feet, respectively. Slope is approximately 2%.

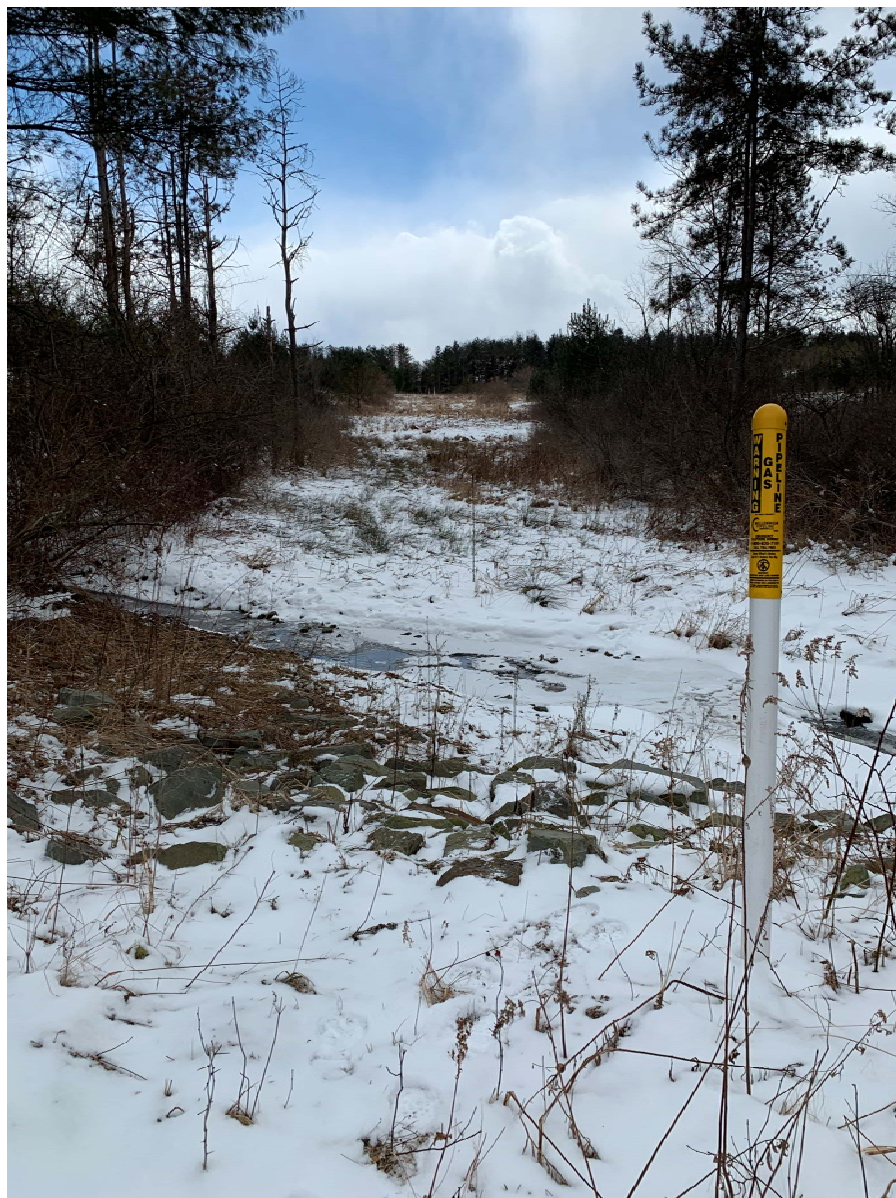
Figure 13. Broad floodplain at pipeline crossing at Ht-9600. Photo taken March 6, 2019.

Project number	Type	Description	Photo or image reference
Ht-9600	Floodplain Reconnection	Floodplain wetland, rare in the watershed, is present immediately upstream of project site. Install engineered large wood and/or rock to raise grade level, improve protection at natural gas pipeline crossing, and enhance flood storage in the natural wetland. Treatment would start a short distance downstream of the pipeline crossing and extend upstream for approximately 200 feet. Valley is broad; treatment would be focused in channel.	Figure 13
Ht-9300	Grade Control	Downstream limit of lower gradient headwater reaches. Location of small knickpoint. Install engineered large wood and/or rock to establish grade control, control headcutting, and encourage reconnection of the channel to its floodplain. Length of treatment would be approximately 100 feet. Valley is broad; treatment would be focused in channel.	Figure 14

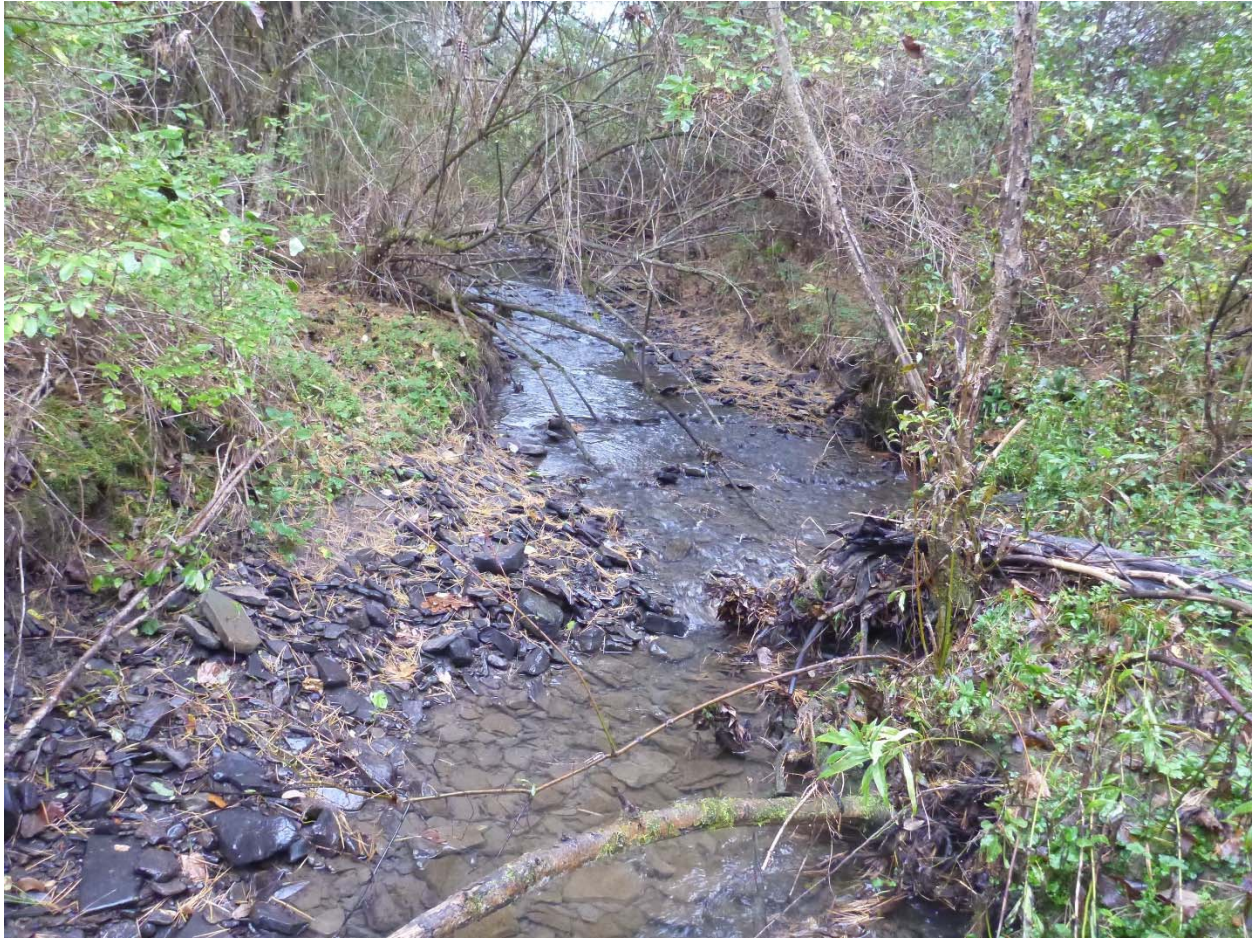
Figure 14. Small knickpoint at downstream limit of treatment reach Ht-9300

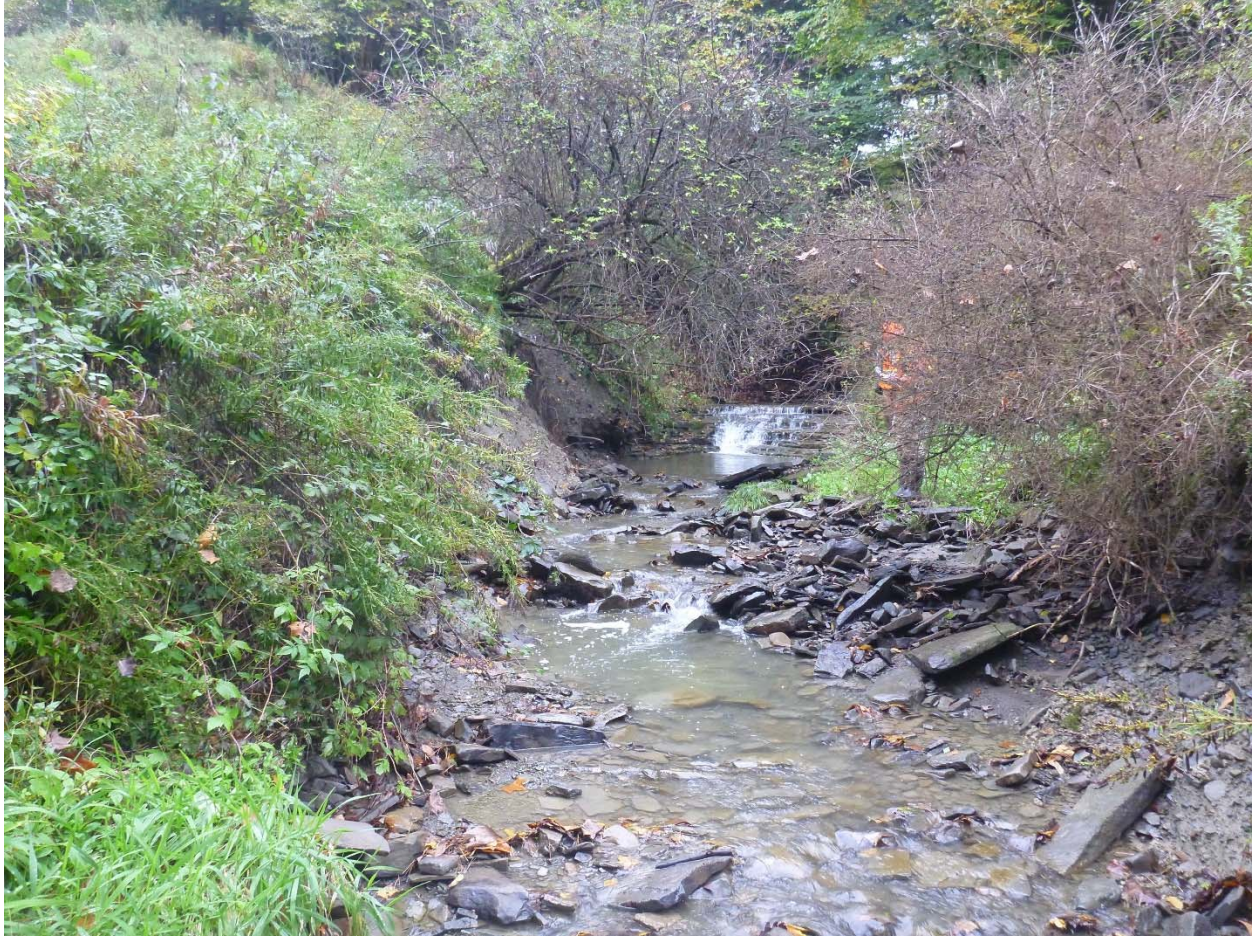
Figure 15. Looking upstream at bedrock control forming upstream limit of treatment reach Ht-7500. Note open canopy and steep, erodible bank toe on river right (left side of photo).

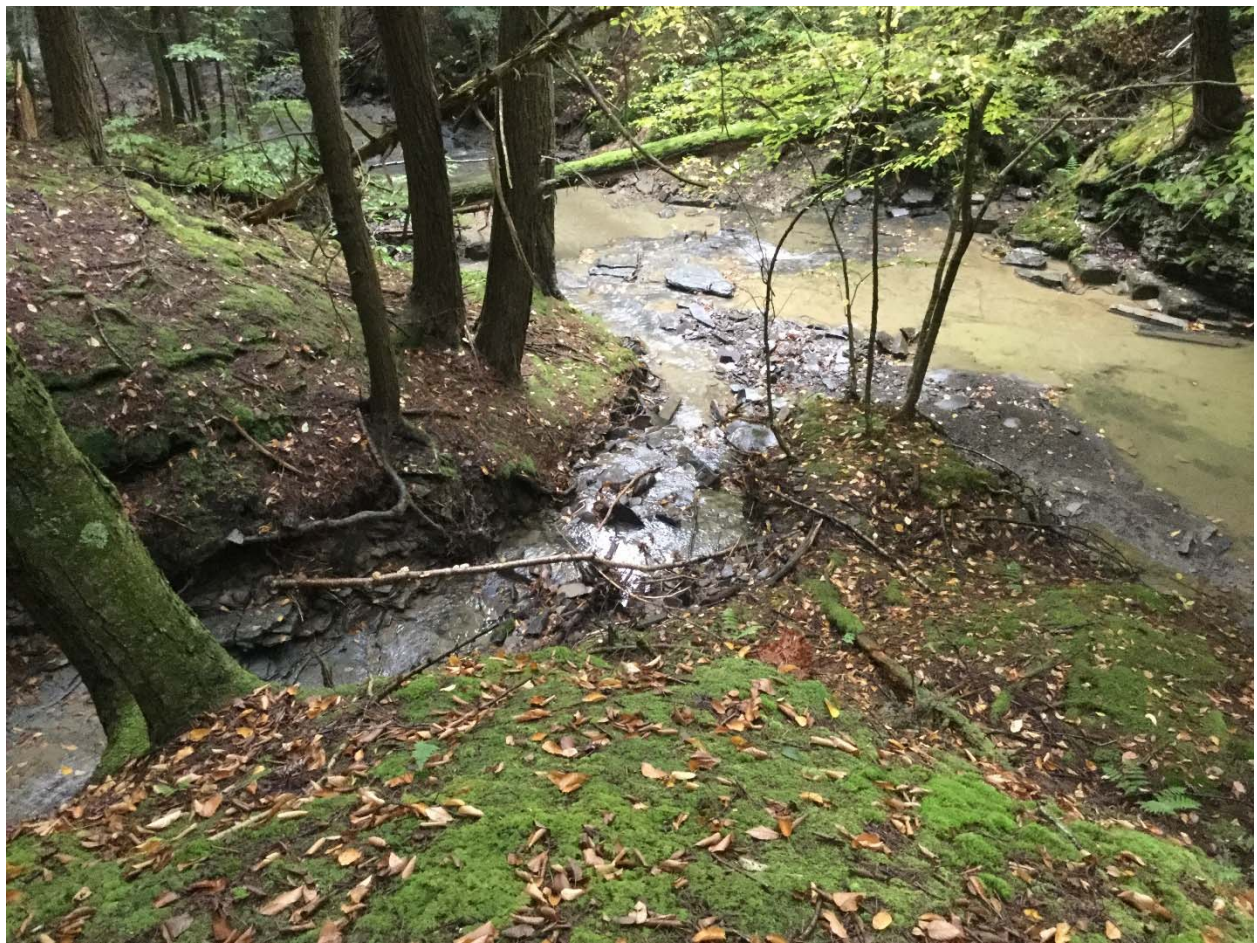
Figure 16. Small channel entering Huntington Creek at Ht-7000

Ht-8500	Floodplain Reconnection	Low-gradient reach with opportunity to utilize storage potential along the valley floor. Install engineered large wood spanning the channel and valley to raise grade level and reconnect the channel to its floodplain. Length of treatment would be approximately 500 feet.	-
Ht-7500	Bank Stabilization	Stripping of woody vegetation for power lines and a plunge pool at the downstream end of a bedrock-controlled reach have resulted in scour and undermining of the banks and bank failure and erosion. Lay back the banks to a more stable slope and stabilize the toes of the banks using bioengineering techniques involving large wood and/or rock and native seeding and planting. Bank length is approximately 100 feet.	Figure 15
Ht-7000	Riparian Management	Two small tributaries deliver runoff and inputs of coarse sediment and silt. Install engineered large wood along both drainages to slow surface runoff, promote infiltration, trap coarse sediment, and promote settling of silt.	Figure 16

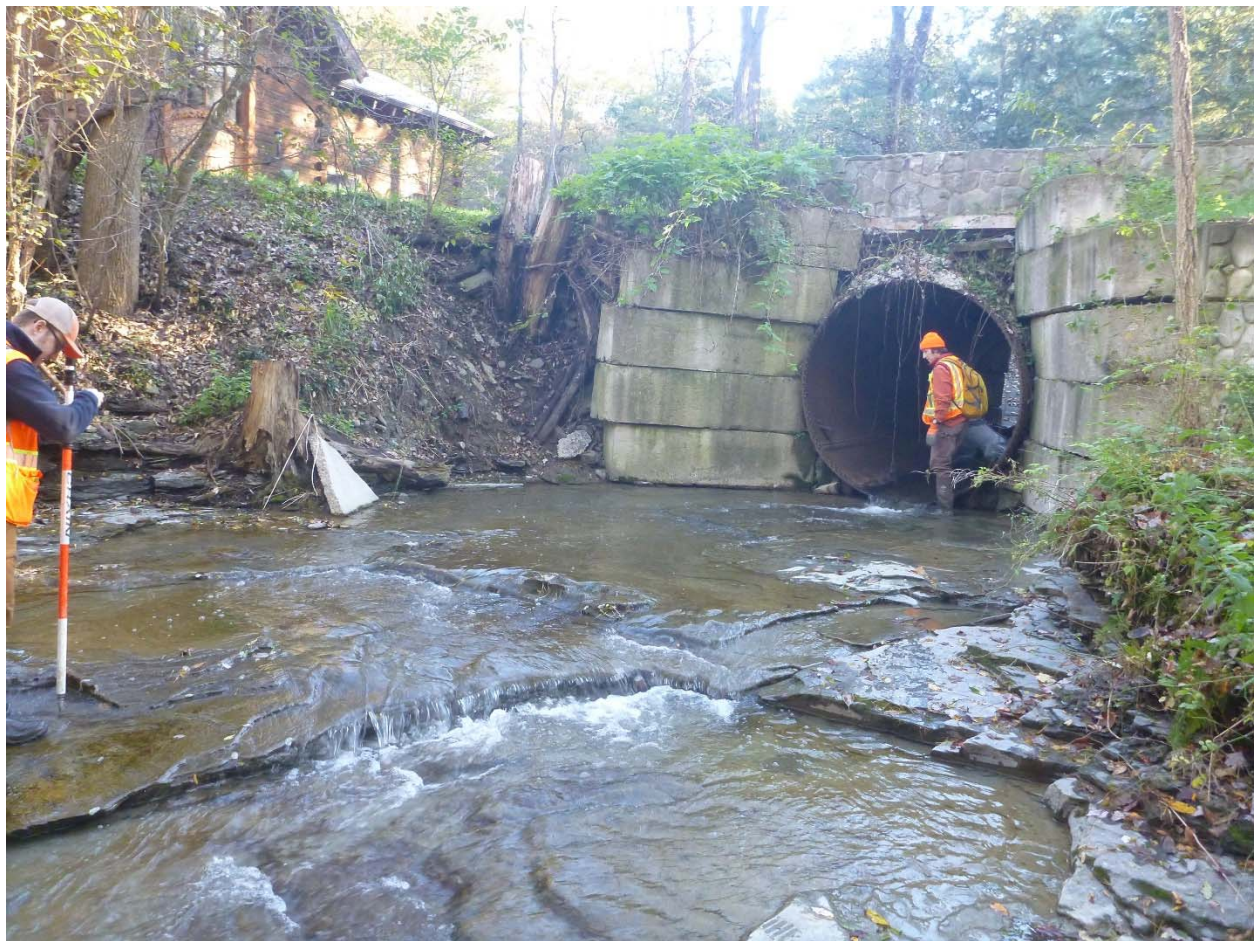
Figure 18. Looking upstream at culvert beneath private access at Ht-6100

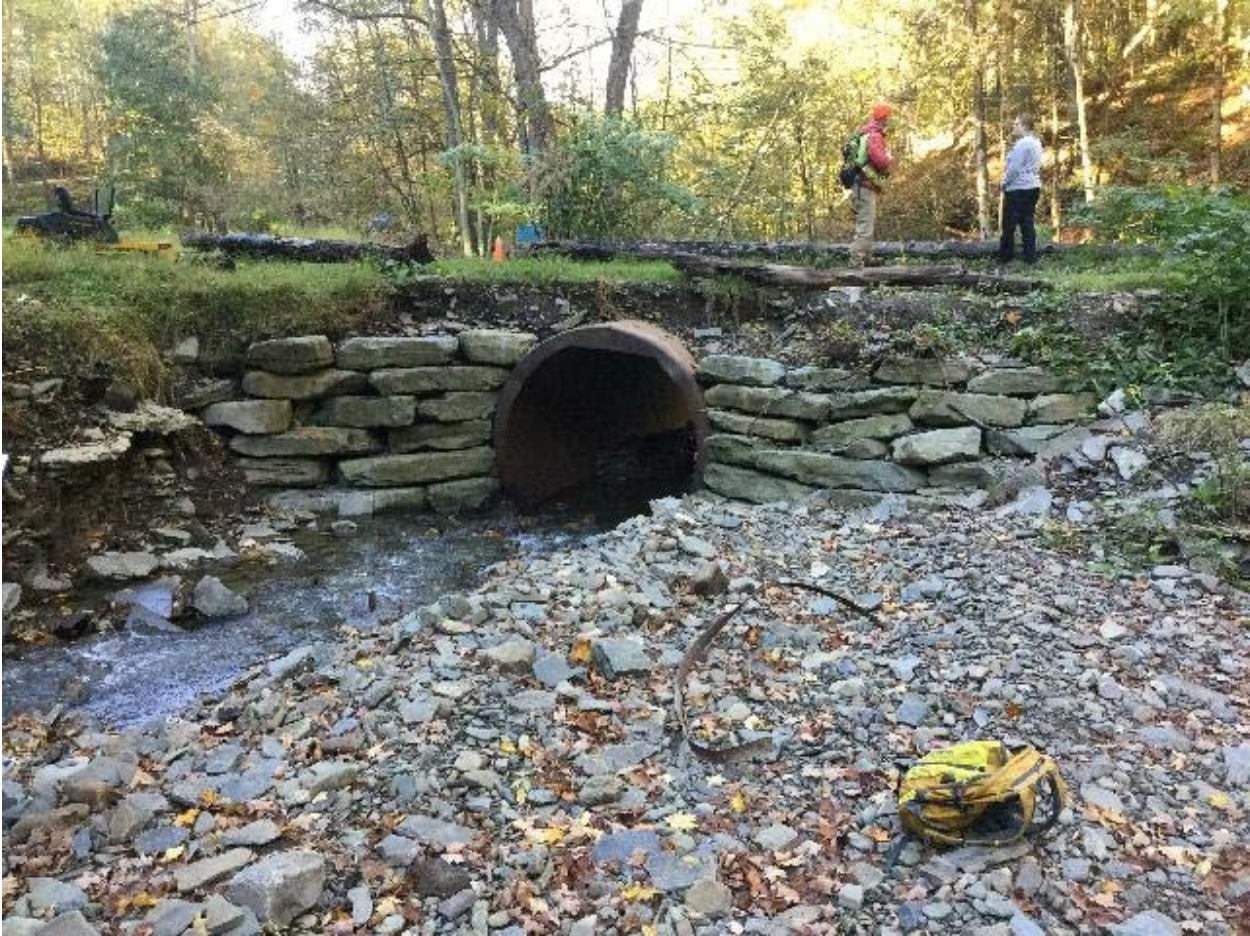
Figure 19. Private access at Ht-4600

Ht-4600	Crossing Improvement	Replace apparently underfit culvert at private access off of Dean Street with an appropriately sized open-bottom structure to reduce flood risk, minimize blockage by woody debris, and improve user safety	Figure 19
Ht-4100	Structure Removal	Site is located in a natural zone of deposition where a small channel draining the northern hillside empties into Huntington Creek. Vegetation has been removed, the creek has been straightened, secondary channels have been filled, and a private access bridge has been installed. Activity has reduced channel sediment storage potential, reduced the creek's natural ability to process sediment, and increased the susceptibility of the banks to erosion. Historically, landowner used private crossing immediately upstream (Ht-4600) to access parcel. Revert to shared crossing by removing the bridge, which is in poor condition, and reinstating access via the improved culvert at Ht-4600. Restore to multi-threaded channel with functional floodplain. Project length is approximately 300 feet.	Figure 20

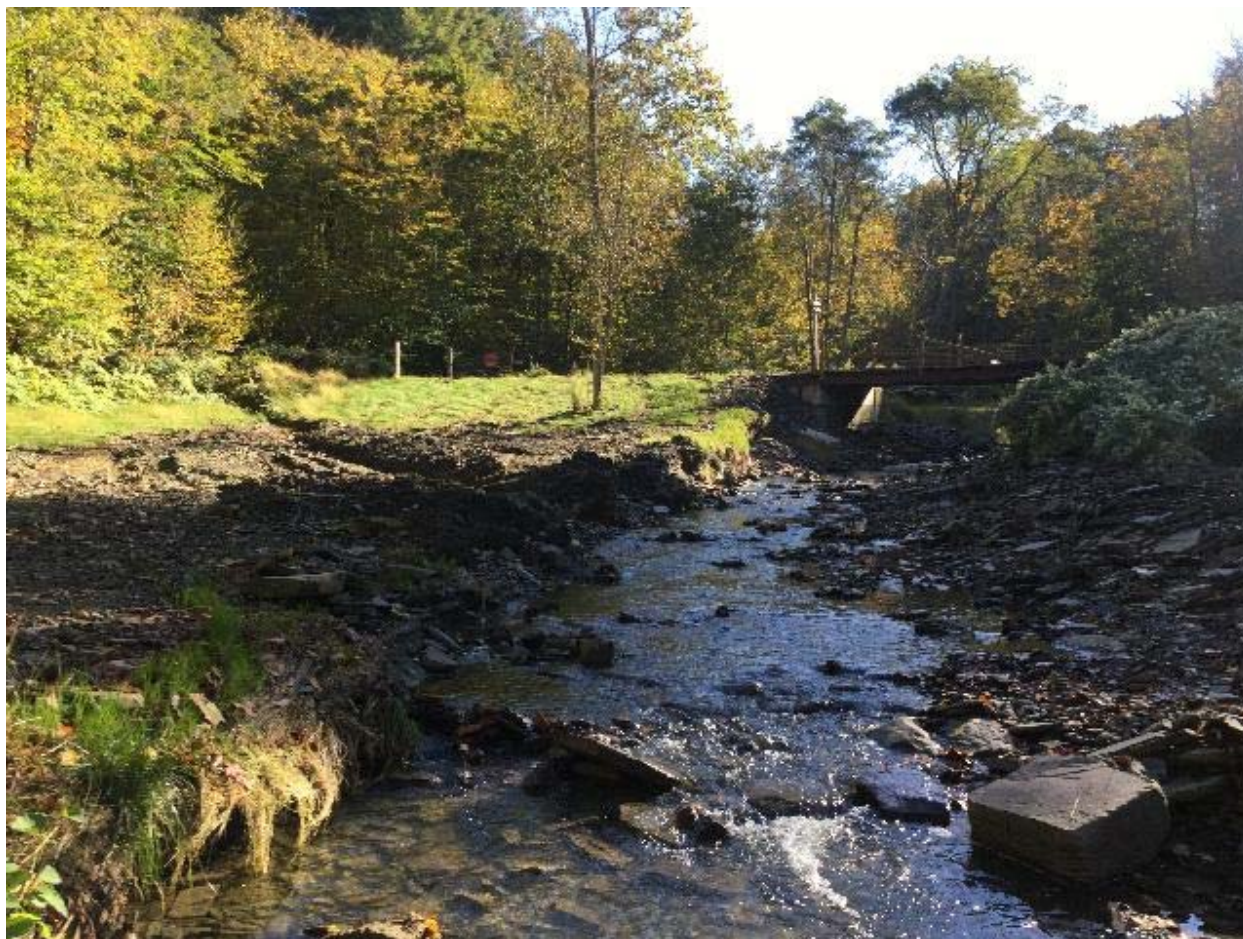
Figure 20. Looking upstream at cleared area around private access at Ht-4100. Note small drainage channel entering channel from river right (left side of photo).

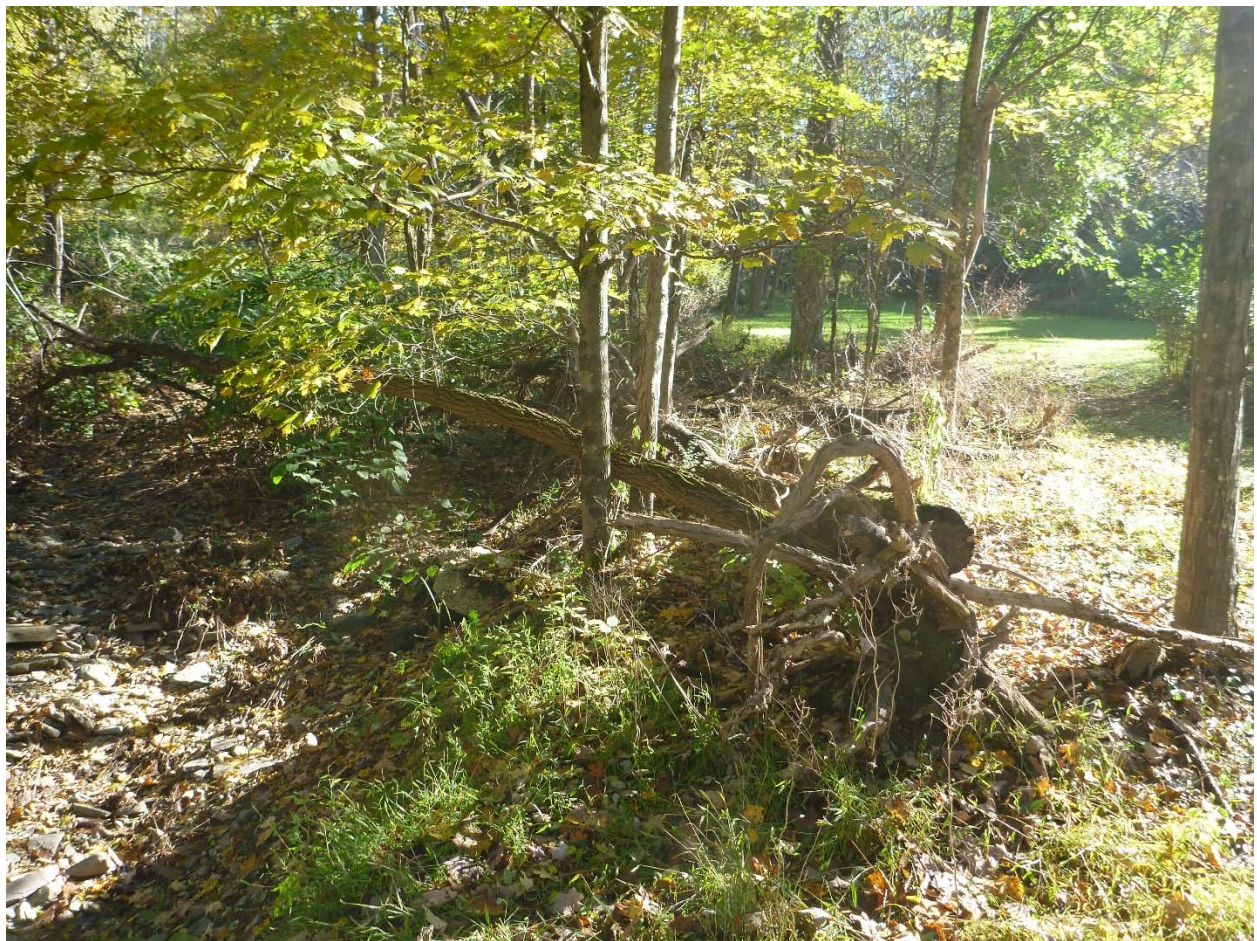
Figure 21. Channel and floodplain at Ht-3700

Ht-3700	Floodplain Reconnection	Site is multi-threaded with proximal floodplain. Install engineered large wood spanning the channel and valley to raise grade level, enhance detention of flood flows in overbank areas, and help trap coarse sediment. Length of treatment would be approximately 300 feet.	Figure 21
Ht-3300	Floodplain Reconnection	Site is downstream of the third branch, which delivers large volumes of coarse sediment to the creek. Install engineered large wood spanning the channel and valley to raise grade level, enhance detention of flood flows in overbank areas, and help trap coarse sediment. Length of treatment would be approximately 300 feet. The work would include invasive plant treatment/removal (Japanese knotweed) and seeding and planting native riparian species.	Figure 22

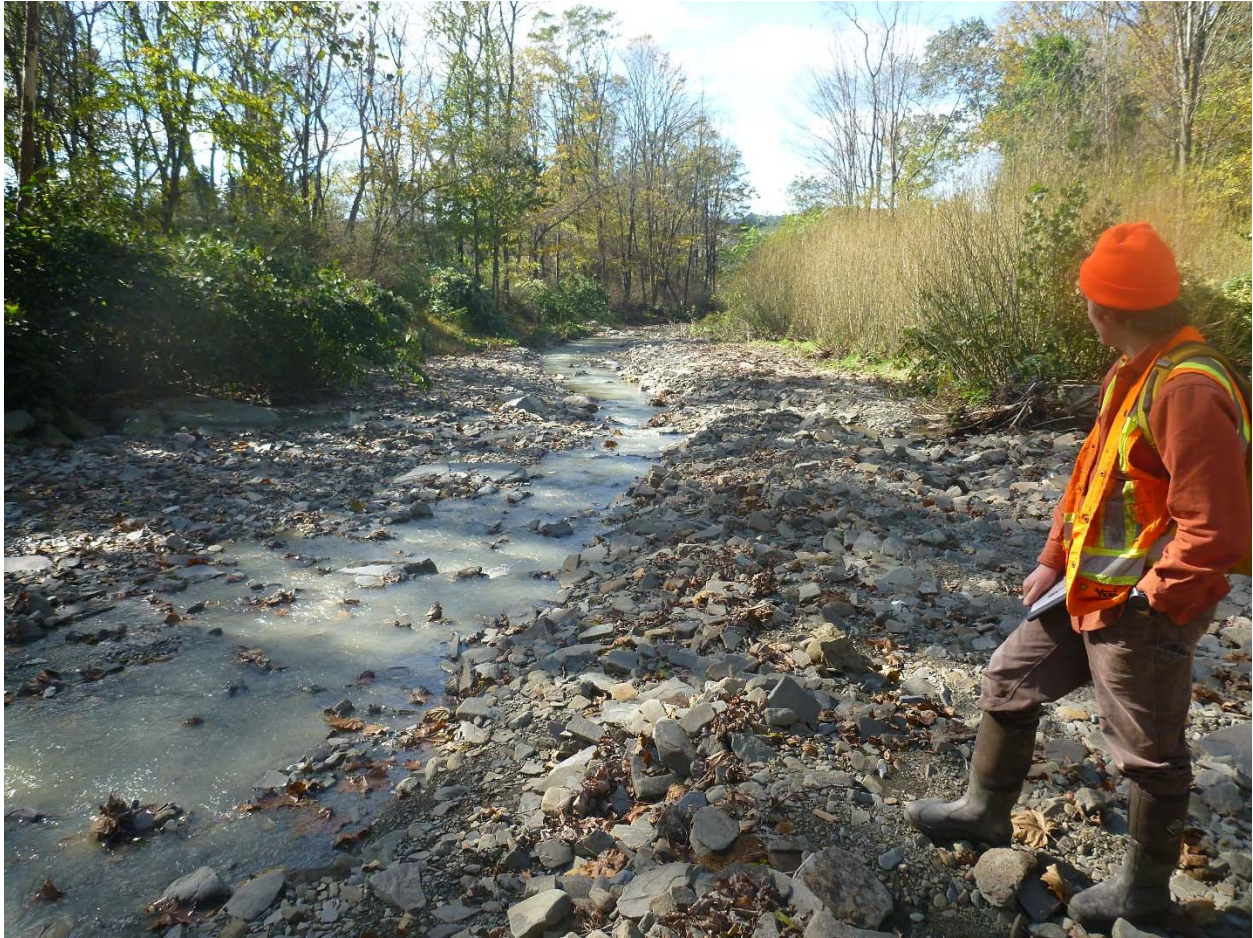
Figure 22. Looking downstream at Ht-3300

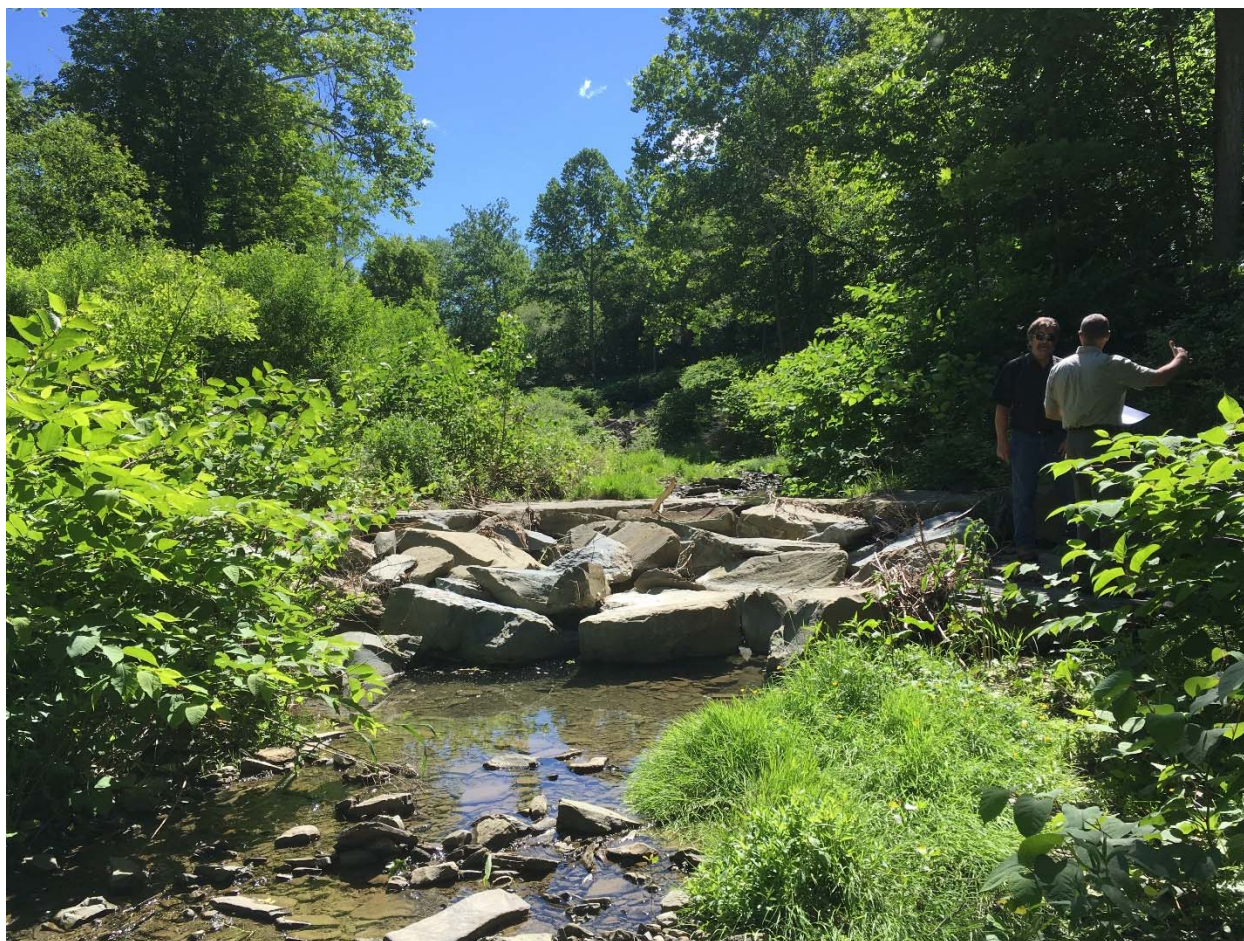
Figure 23. A portion of the NRCS grade control project at HT-3000. Note large boulders and lack of surface flow over the structure. Photo taken June 14, 2018.

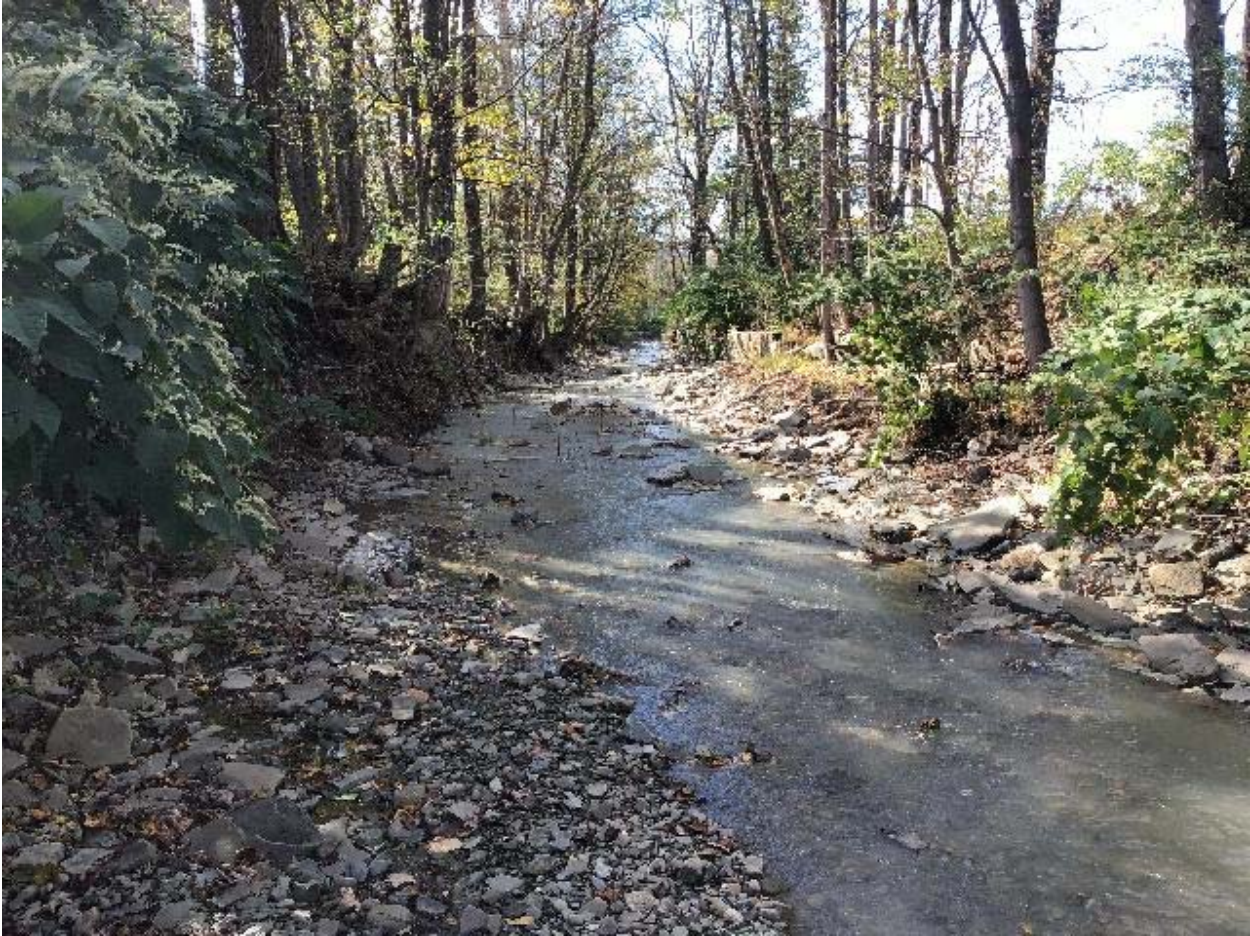
Figure 24. Huntington Creek between Route 96 and Sheldon Guile Boulevard at Ht-1850

Project number	Type	Description	Photo or image reference
Ht-3000	Barrier Removal	Site of a relatively recent NRCS grade control project. Substantial voids exist in large rock used to construct grade control structure resulting in poor habitat quality, barrier to aquatic organism passage, and subsurface flow during low flow. Monitor the site over the anticipated lifespan of the project, review effectiveness, and weigh options for mitigating fish passage issues. Consider reconstructing grade control in a more ecologically sensitive manner. Future work should include invasive plant treatment/removal (Japanese knotweed) and seeding and planting native riparian species.	Figure 23
Ht-1850	Riparian Management	Site is located in a natural zone of deposition between Route 96 and Sheldon Guile Boulevard. Channel is laterally constrained, experiences substantial deposition on the bed, and requires regular dredging to maintain conveyance capacity. Remove walls and berms, widen floodplain, and allow channel to migrate laterally. Length of reach is approximately 400 feet.	Figure 24
