**Tioga County Industrial Development Agency
July 10, 2019 • 4:30pm•
Ronald E. Dougherty County Office Building
56 Main Street, Owego, NY 13827
Agenda**

Huntington Creek Background Report

**Susquehanna Geomorphic Assessment
Huntington Creek**

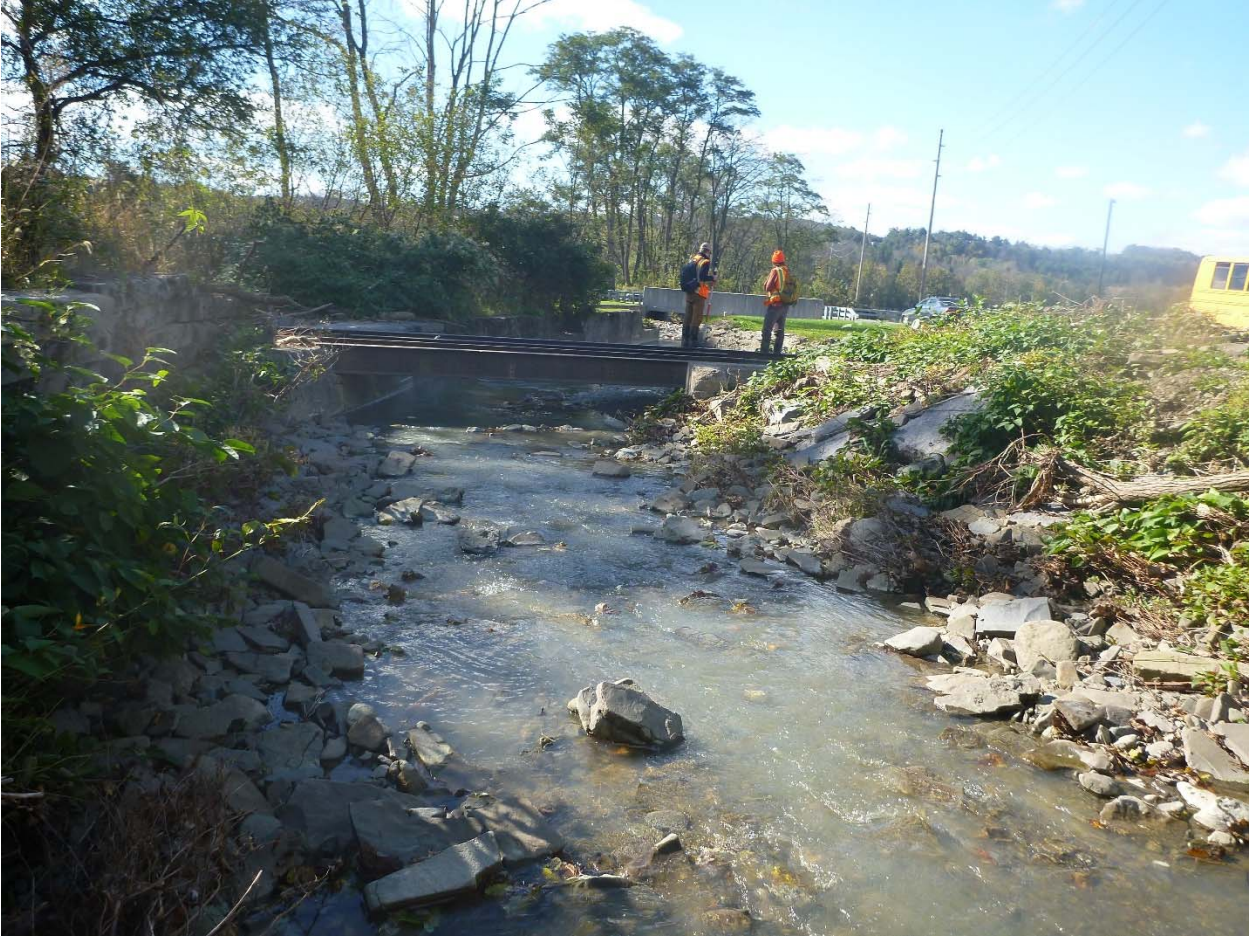
Figure 25. Looking downstream at the railroad crossing at Ht-1800

Ht-1800	Crossing Improvement	Raise and lengthen the railroad crossing to improve conveyance capacity and accommodate a wider channel and floodplain	Figure 25
Ht-1700	Crossing Improvement	The current alignment of the Sheldon Guile Boulevard bridge restricts floodplain width along Huntington Creek. The existing box culvert crossing is undersized and choked with sediment. Relocate/realign the section of Sheldon Guile Boulevard between the bus station and crossing to allow for widening of channel and floodplain (Ht-1850). Raise and replace crossing to improve conveyance and accommodate a wider channel and floodplain.	Figure 26
Ht-700	Floodplain Reconnection	Creek has been straightened and constrained by berms. Remove berms to encourage more frequent inundation of adjacent floodplain and provide space for channel to migrate laterally. Initiate recovery by re-meandering the channel along a more natural alignment. Reconstruct a berm set back from the channel to help protect the school from flooding from Huntington Creek. Consider location and orientation of berm that would not adversely interfere with flooding from Owego Creek.	Figure 27

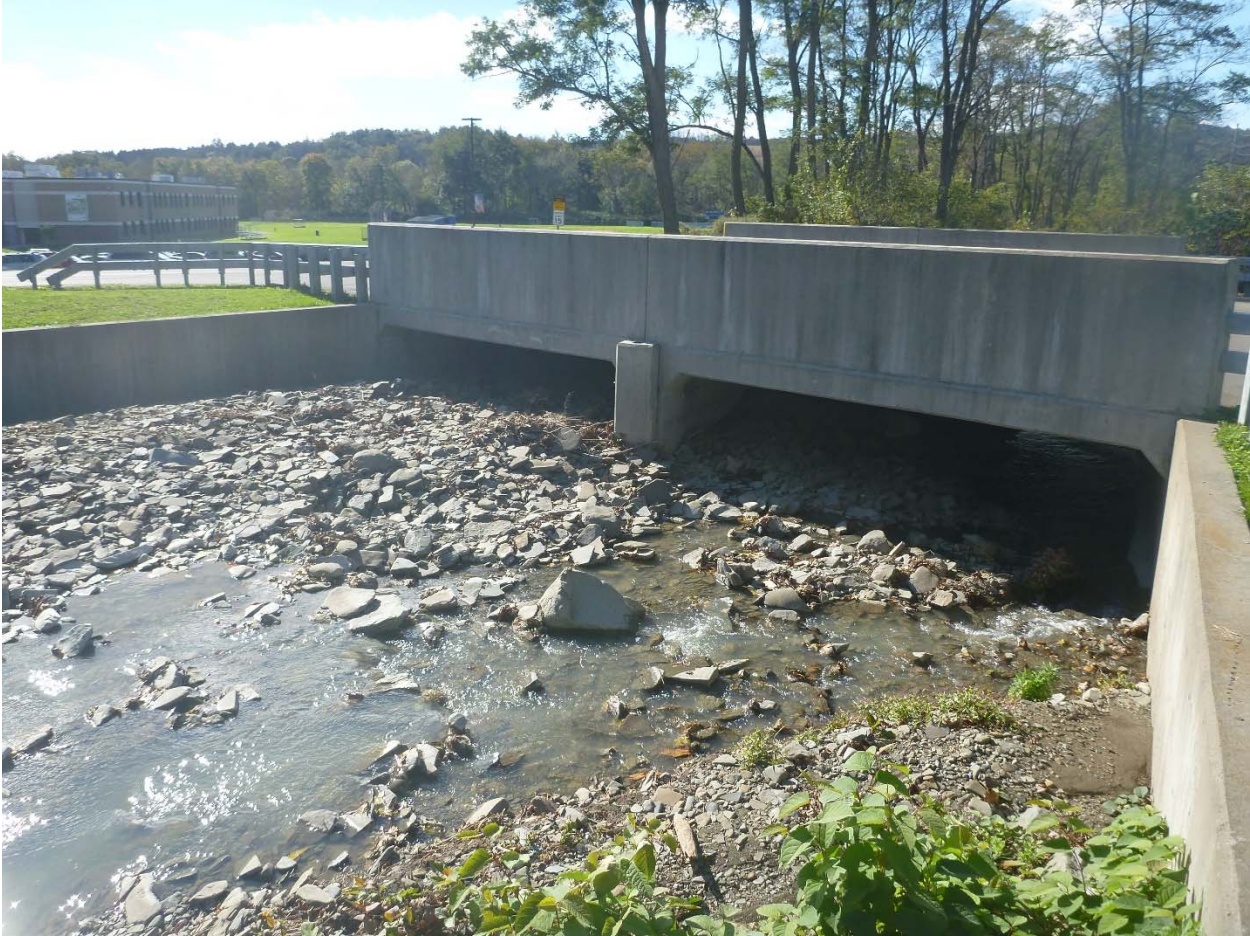
Figure 26. Sheldon Guile Boulevard crossing at Ht-1700

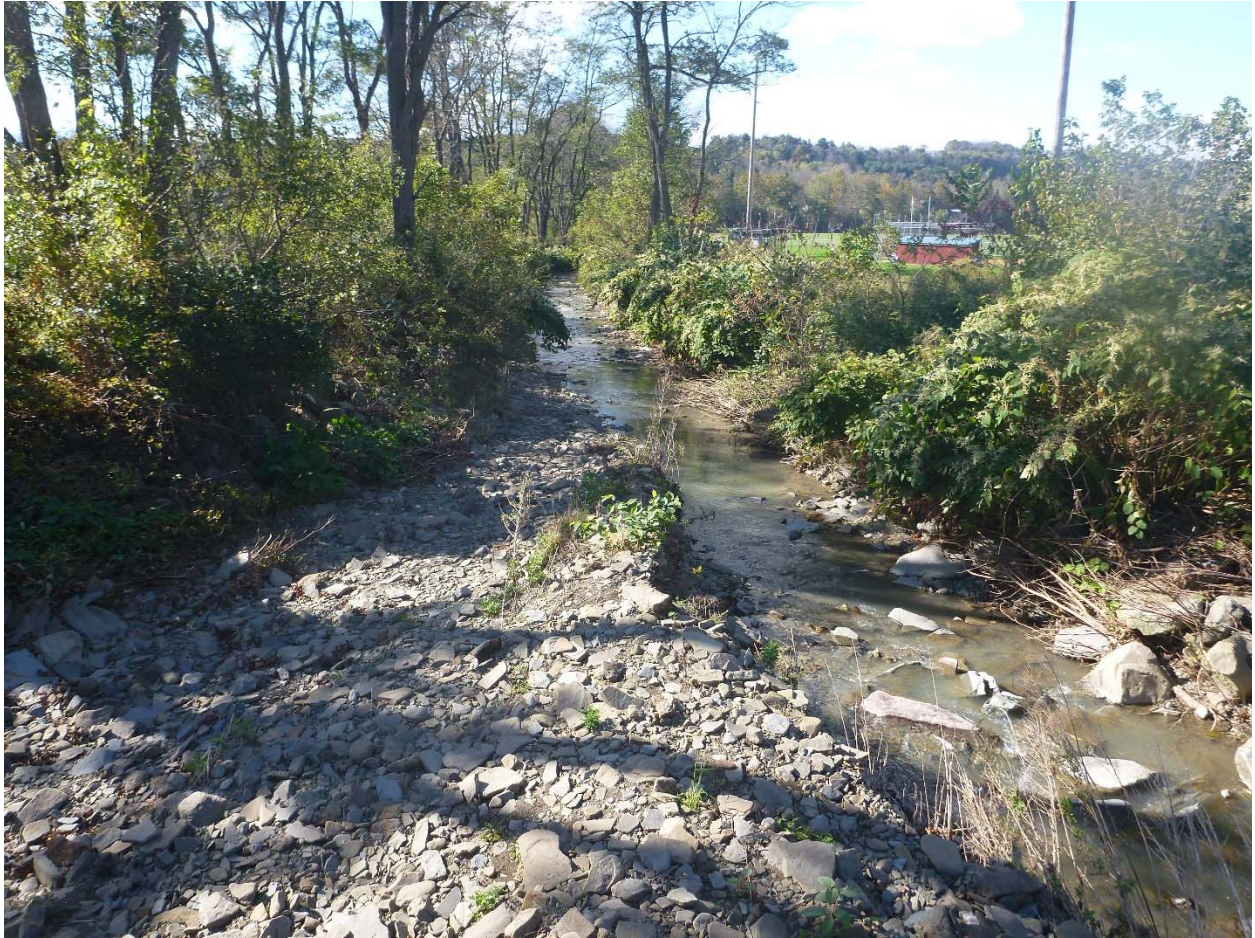
Figure 27. Looking downstream along Huntington Creek between Sheldon Guile Boulevard and the confluence with Owego Creek (Ht-1200)

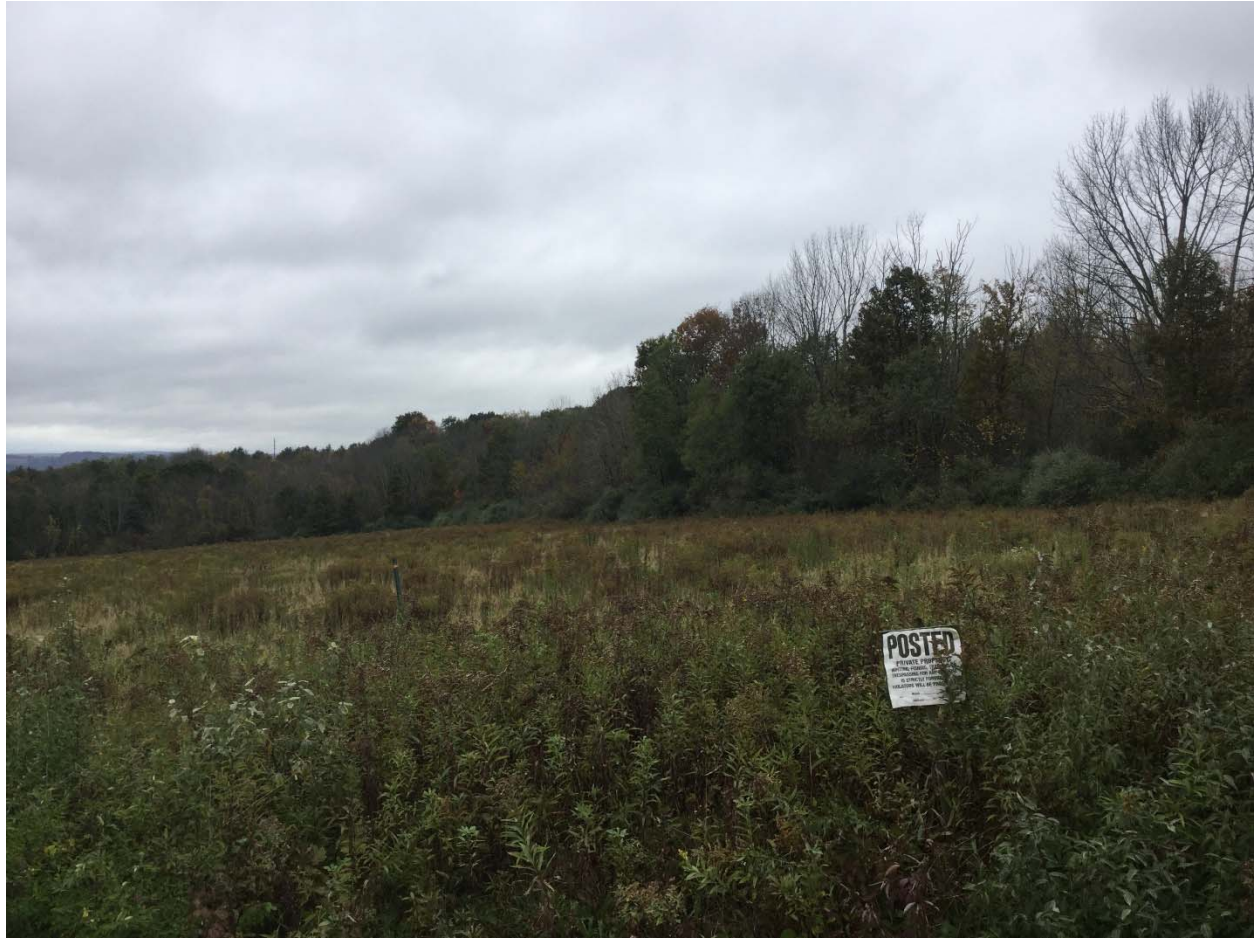
Figure 28. Field along East Beecher Hill Road at Ht1-2200

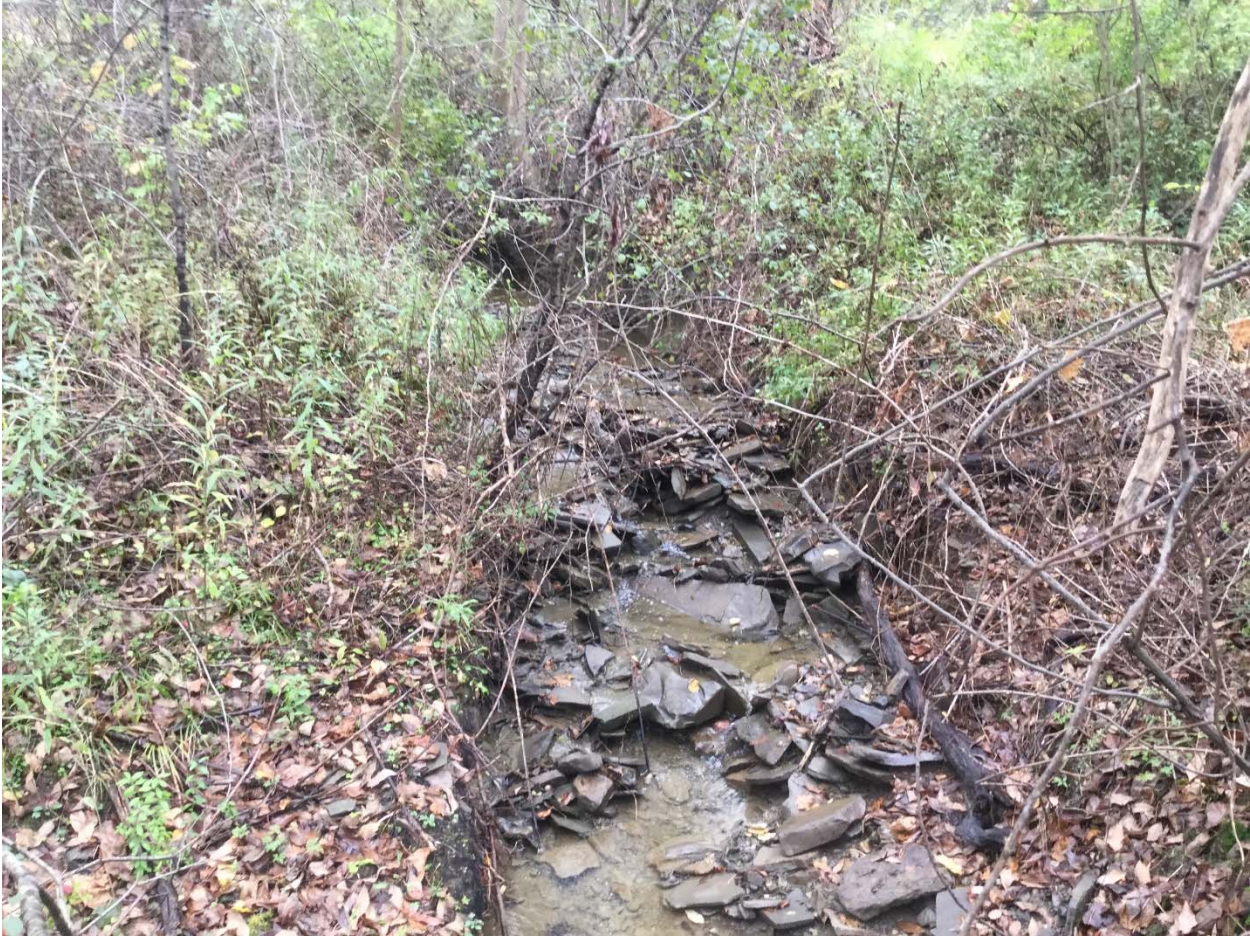
Figure 29. Small channel draining field at Ht1-1800

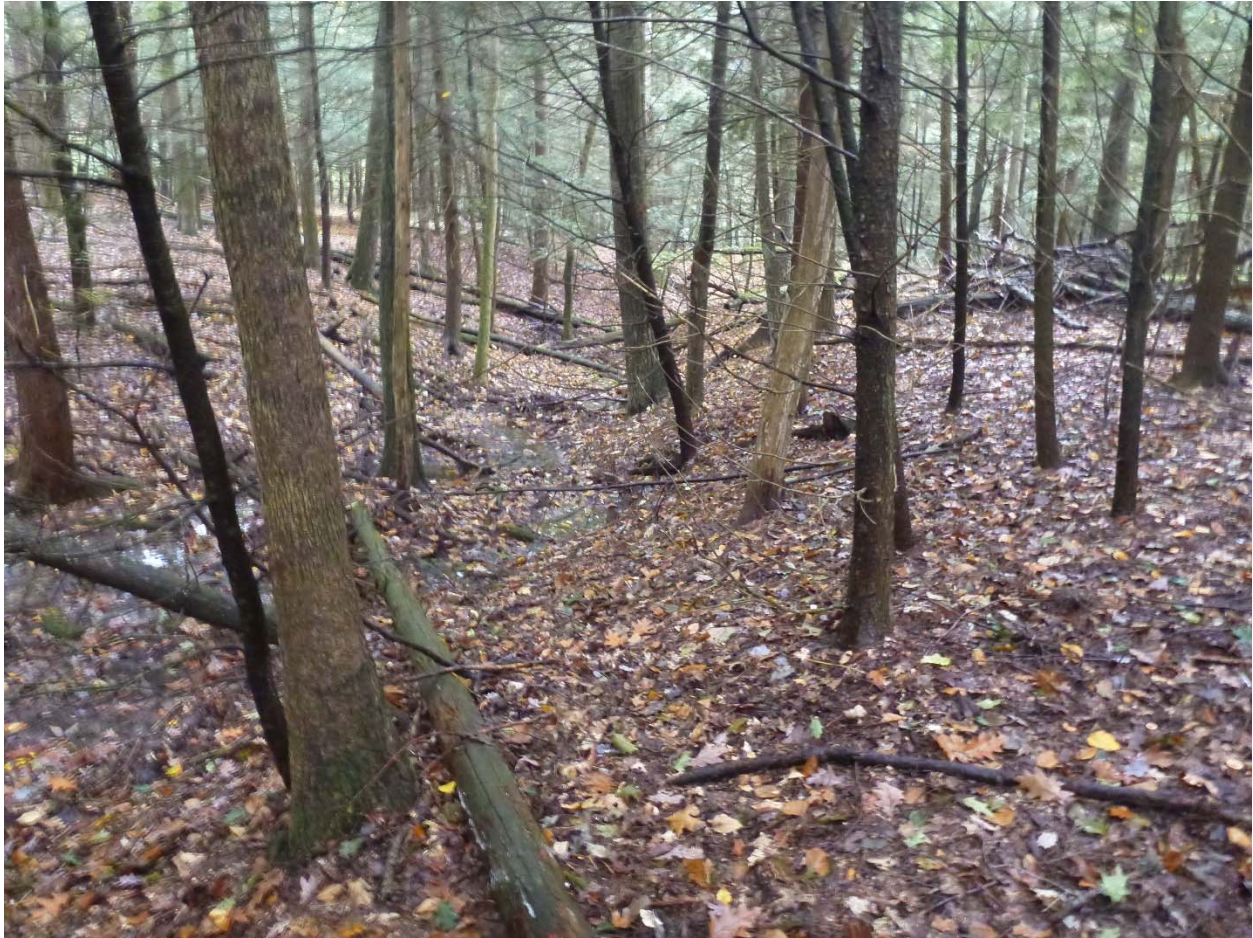
Figure 30. Small channel through forested floodplain at Ht2-700

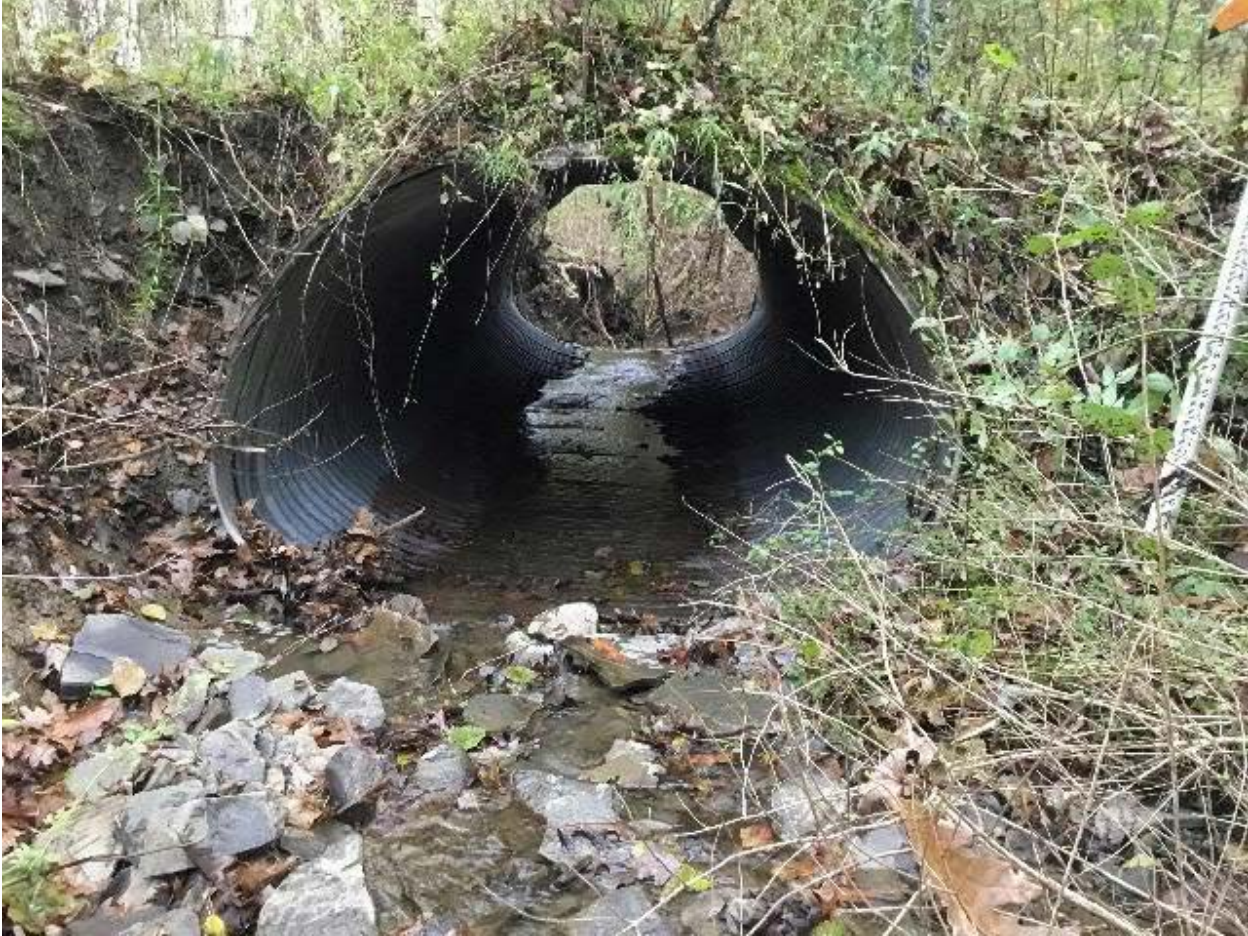
Figure 31. Private field access at Ht3-2700

Project number	Type	Description	Photo or image reference
Ht3-2700	Structure Removal	Existing culvert along a private field access off of Carmichael Road appears undersized and is perched with a deep scour hole and incised channel downstream. The culvert is currently serving as grade control for upstream reaches. Replacement of the culvert would likely be expensive (see Appendix B). Remove the culvert and utilize alternative routes off of Carmichael Road that do not require crossing the creek. Install engineered large wood and/or rock in the downstream reach to establish grade control, reduce the risk of headcutting, and moderate sediment supply. Length of treatment would be approximately 200 feet.	Figure 31
Ht3-2200	Upland Land Management	Implement drainage improvements along Carmichael Road to slow runoff and reduce erosion. Repair road ditches and install ditch relief culverts where opportunities exist to divert flow onto fields and thus promote infiltration. Include adequate erosion protection at culvert outlets.	-

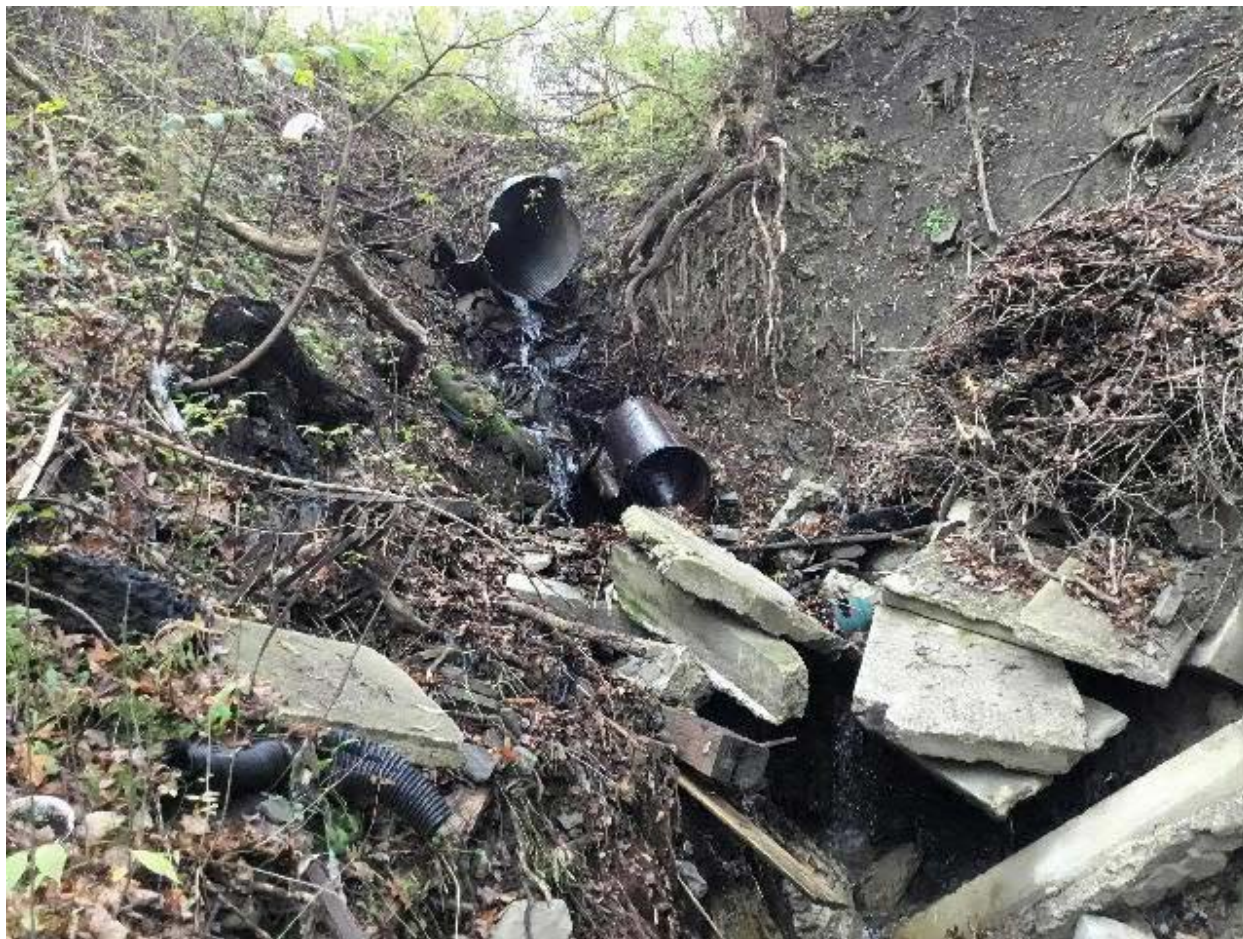
Figure 32. Carmichael Road culvert at Ht3-1900

Ht3-1900	Crossing Improvement	Existing culvert beneath Carmichael Road appears to severely restrict high flows and is in extremely poor condition with a collapsed outlet structure. The downstream channel is severely incised. Install a riffle grade control structure immediately downstream to raise grade level at the crossing. Replace the culvert with an appropriately sized structure at a lower elevation to reduce flood risk and risk to road users. Combine with grading and installation of engineered large wood upstream of the culvert to reduce the risk of headcutting and moderate sediment supply. Implement after Ht3-100.	Figure 32
Ht3-100	Grade Control	The third branch between the confluence and Carmichael Road shows evidence of continued downcutting along the channel bed and drainage channels leading from the road. Bedrock is exposed along the bed in numerous locations. Regrade the banks to a more stable angle where possible and install engineered large wood and/or rock to stabilize the bed, raise grade level, and moderate coarse sediment supply. Length of treatment would be up to 1,500 feet.	Figure 33

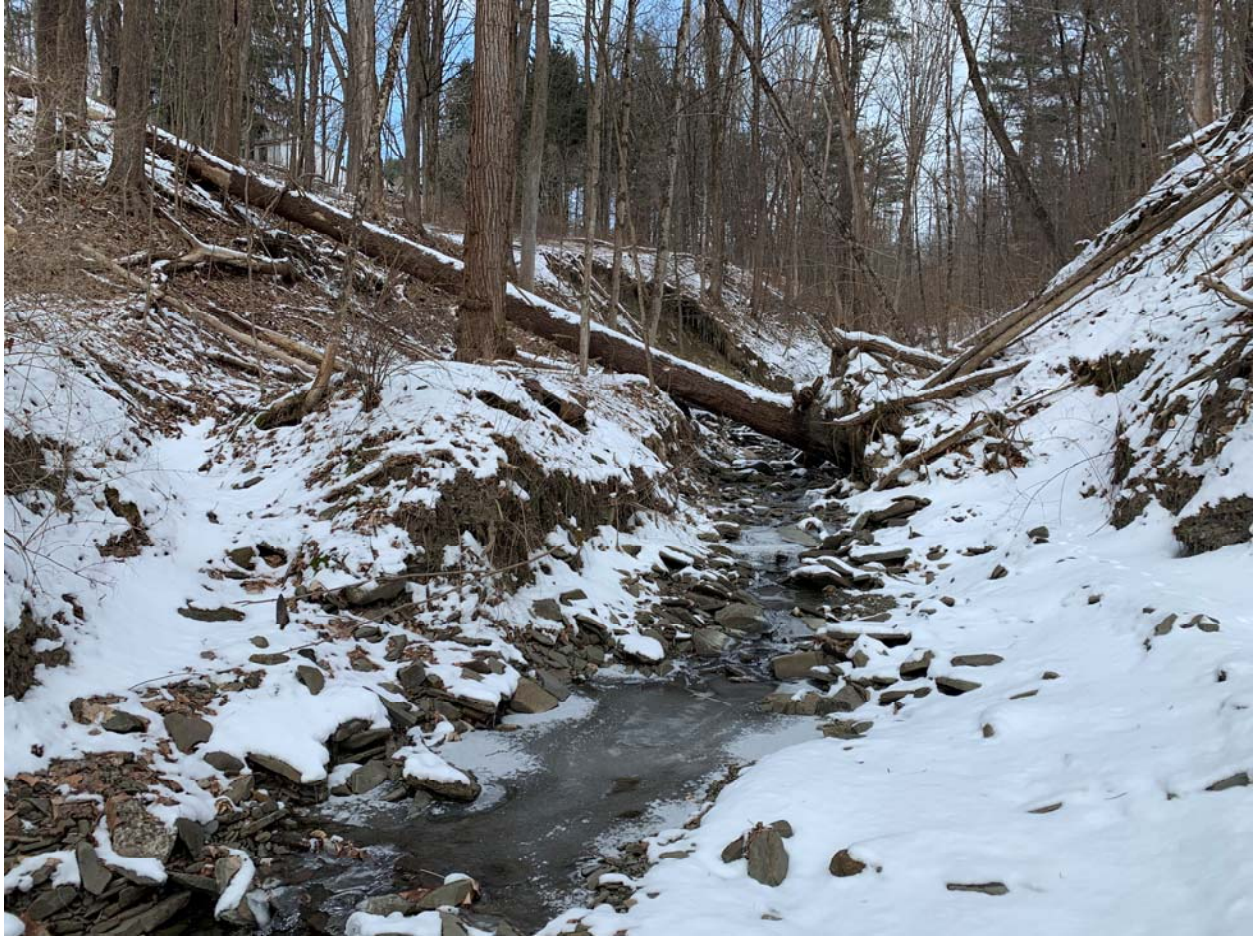
Figure 33. Looking upstream along the incised third branch near Ht3-100. Photo taken March 6, 2019.

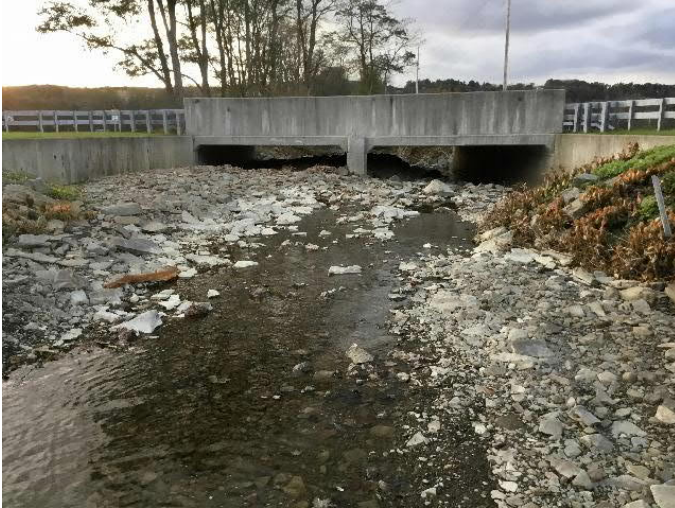
- The structure is severely undersized (estimated capacity is approximately one-tenth of the 10-year peak flow) and clogs frequently during floods.
- Lateral restriction of channel movement by concrete and timber walls along the banks has forced all sediment deposition to occur in the streambed, reducing conveyance capacity.

Inlet of Sheldon Guile Boulevard crossing over Huntington Creek. Note sediment nearly filling culvert structures.

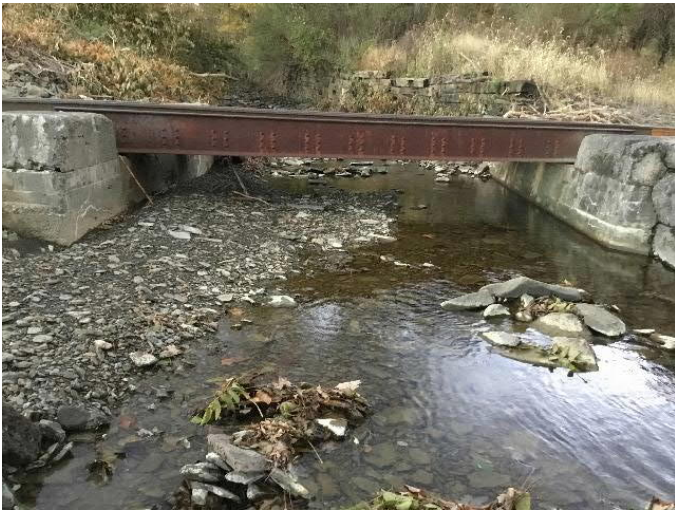
Outlet of Owego & Hartford Railroad bridge over Huntington Creek. Note low bridge clearance, constriction of stream by bridge abutments, and timber retaining wall lining upstream channel.

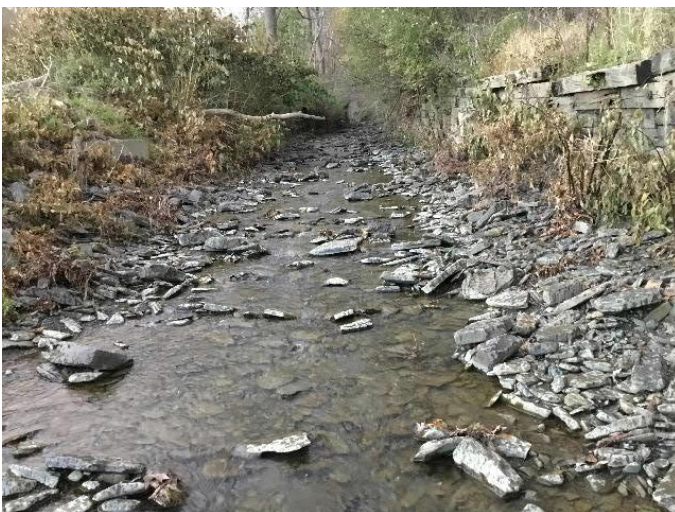
Huntington Creek channel upstream of Owego & Hartford Railroad bridge. Note leaning timber retaining wall lining stream channel on river left (right side of photo).

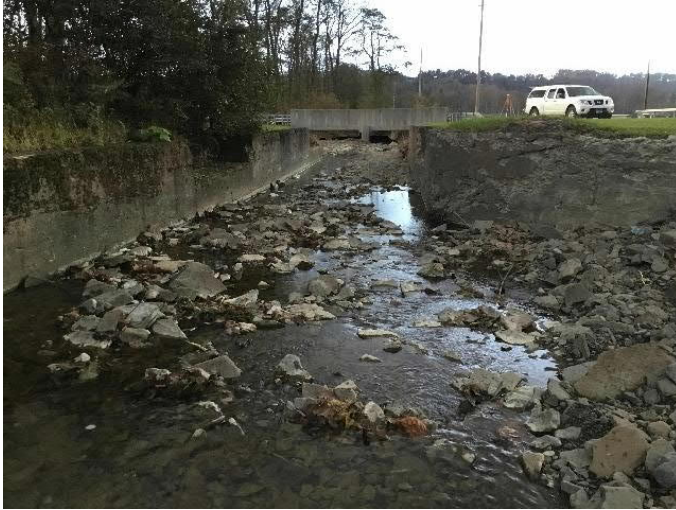
Huntington Creek channel downstream of Owego & Hartford Railroad bridge, looking toward Sheldon Guile Boulevard bridge. Note the concrete retaining walls lining the channelized stream.

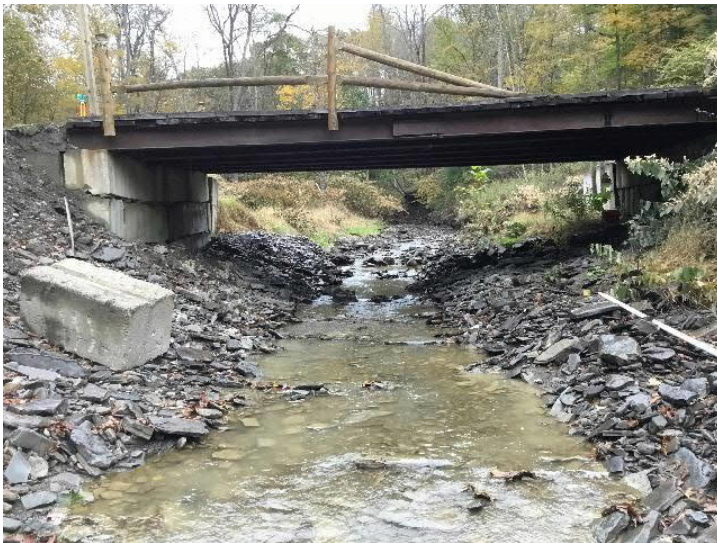
- Abutments and wingwalls are in poor condition (sagging or collapsed).
- A ford crossing is located just upstream of the crossing.
- Some planks in the wooden bridge deck are deteriorated or completely rotten. Planks have been placed over the bridge deck lengthwise to support vehicles.
- Natural sediment deposition may have been modified by channel work using heavy equipment.

Private Driveway off Dean Street over Huntington Creek (downstream). Structure inlet. Note sagging abutment and displaced concrete waste block on left bank.

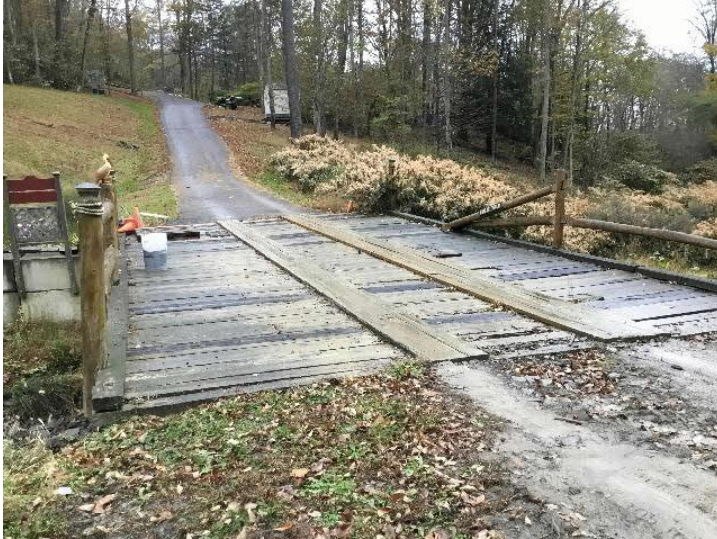
Private Driveway off Dean Street over Huntington Creek (downstream). Photograph of bridge deck. Note planks placed lengthwise on bridge deck to support vehicle traffic.

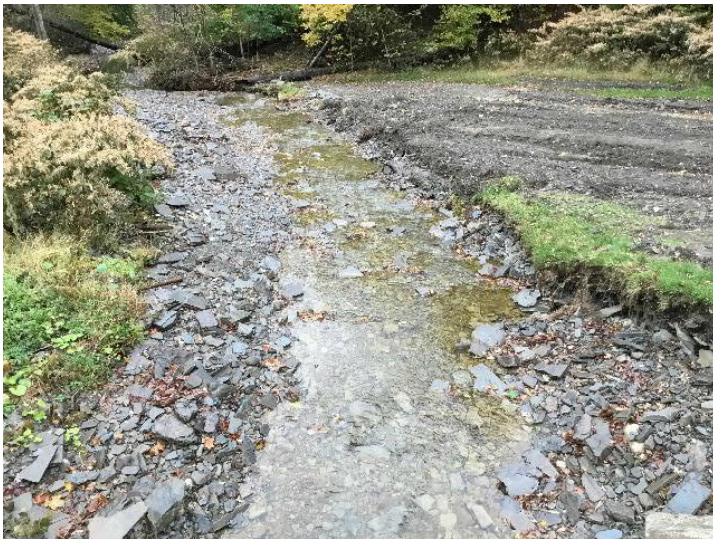
Private Driveway off Dean Street over Huntington Creek (downstream). Area of heavy machinery work in channel downstream of crossing structure.

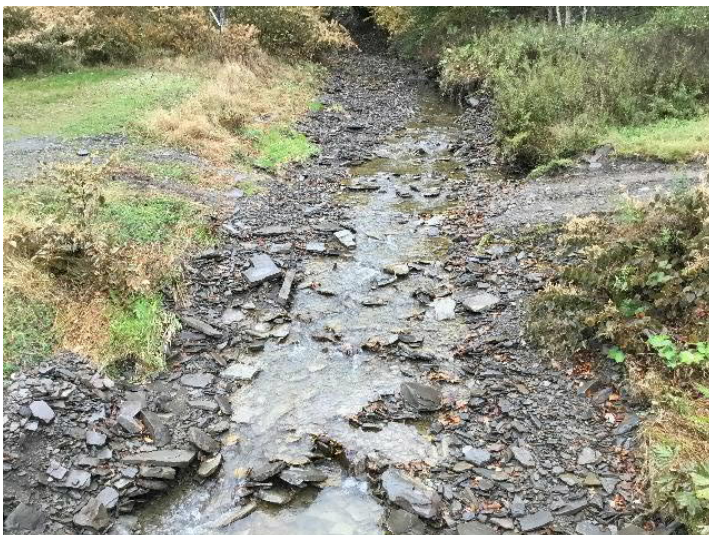
Private Driveway off Dean Street over Huntington Creek (downstream). Ford upstream of crossing structure.

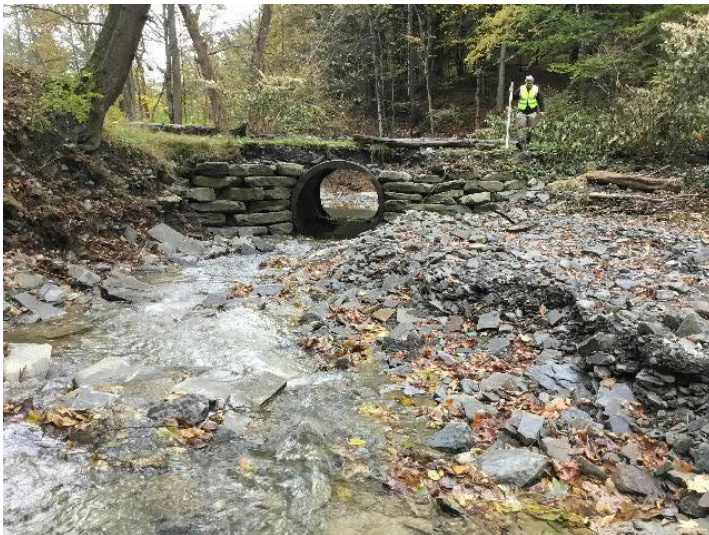
- The crossing structure is constructed from an old, repurposed steel tank and severely constricts flow. The crossing is undersized hydraulically, with an estimated capacity less than the 10-year return interval flood event.
- The homeowner stated that the crossing has overtopped three times in the two months prior to the crossing survey. These events caused serious erosion to banks and road fill. The homeowner also indicated that they have lost at least 3 feet of driveway width on both sides of the crossing. At the time of the crossing survey, they were unable to receive deliveries of heating fuel or firewood due to the crossing's poor structural condition.
- At the crossing outlet, the road embankment slope is nearly vertical or overhanging and very unstable.
- Sediment deposition was observed in the upstream and downstream channel.

Private Driveway off Dean Street over Huntington Creek (upstream). Structure inlet. Note erosion of road along top of structure, and sediment deposition on river right.

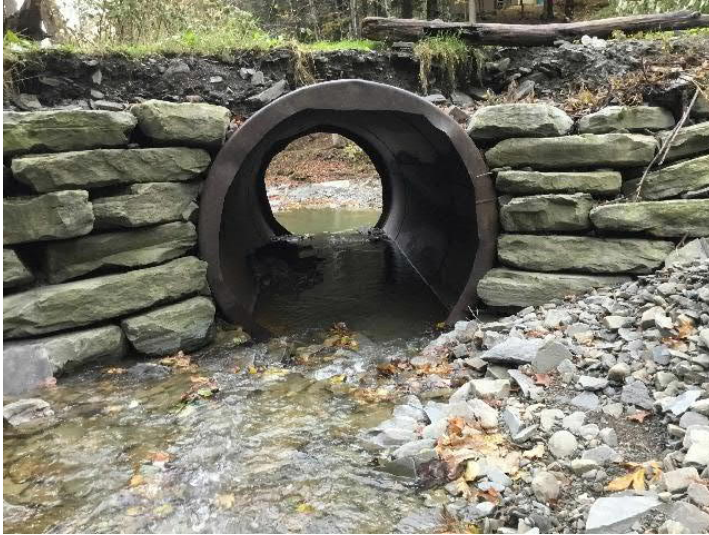
Private Driveway off Dean Street over Huntington Creek (upstream). Close-up photograph of structure inlet. Note inadequate fill/cover material above culvert, erosion of road along top of structure, and sediment deposition on river right.

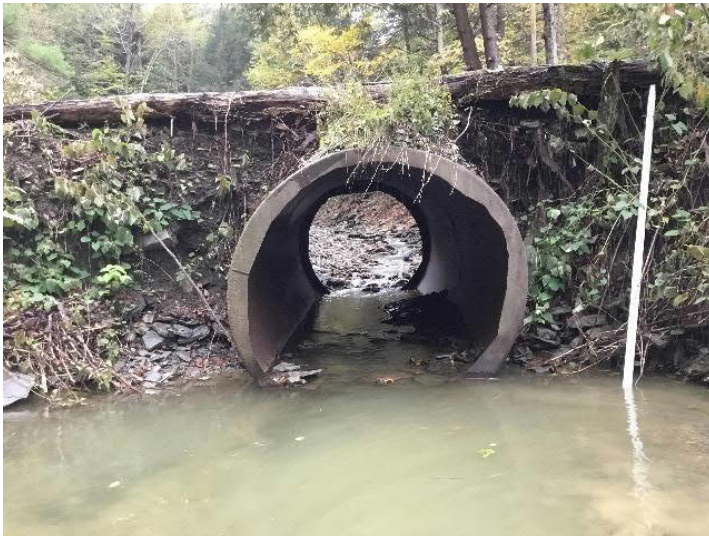
Private Driveway off Dean Street over Huntington Creek (upstream). Crossing structure outlet. Note erosion of road embankment on either side of structure.

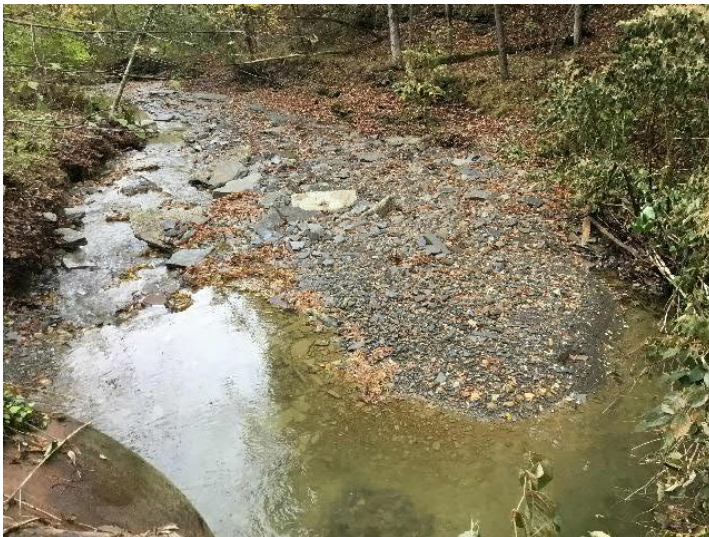
Private Driveway off Dean Street over Huntington Creek (upstream). Streambank erosion on river left and deposition on river right, downstream of crossing structure.

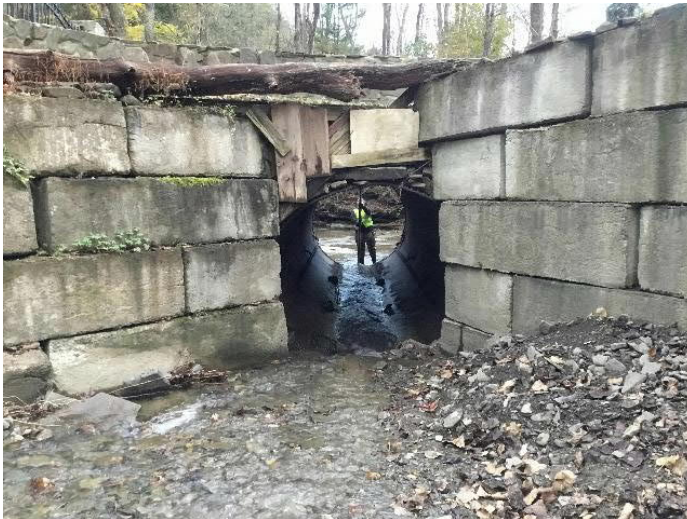
- The crossing structure is in extremely poor condition and could threaten vehicle safety
 - Headwalls are no longer in place, replaced by plywood scraps
 - Wingwalls are misaligned.
- The crossing structure is constructed from an old, repurposed steel tank and severely constricts flow. The crossing structure is constructed from an old, repurposed steel tank and severely constricts flow, with an estimated hydraulic capacity less than the 10-year return interval peak flow.
- The culvert's perched outlet limits aquatic passage.
- Natural sediment deposition may have been modified by channel work using heavy equipment.

Private (Winery) Driveway off Allen Glen Road over Huntington Creek. Structure inlet. Note plywood in place of headwall and misaligned wingwalls.

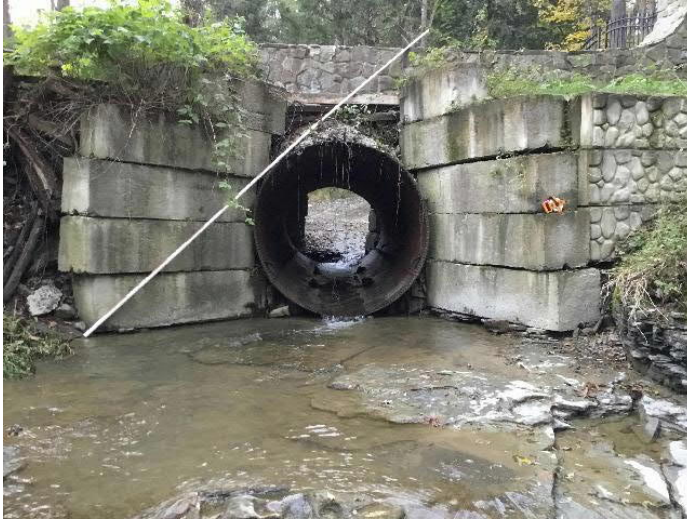
Private (Winery) Driveway off Allen Glen Road over Huntington Creek. Structure outlet. Note debris and plywood in place of headwall and severely misaligned wingwalls.

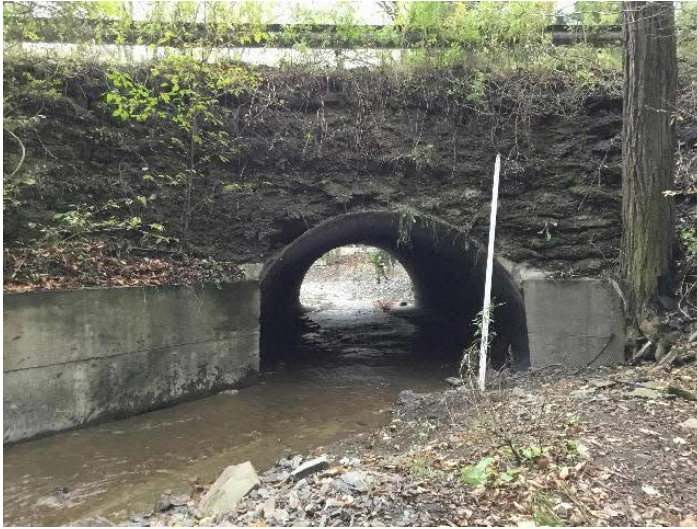
- The structure is adequately sized to convey the 100-year return interval peak flow but serves as a constriction given its width relative to bankfull width.
- The perched outlet limits/prohibits aquatic passage.
- The wingwalls are in critical condition (near collapse).
- The upstream headwall is completely gone. The road appears to be supported by stacked bags of grout that were installed behind the missing headwalls when it was installed.
- Material has eroded from the road embankment, threatening the roadway integrity.
- The streambed consists of a concrete-lined channel for approximately 130 feet, extending upstream, through, and downstream of the structure.

Allen Glen Road over Huntington Creek. Structure inlet. Note missing headwall exposing embankment formed of stacked bags of grout.

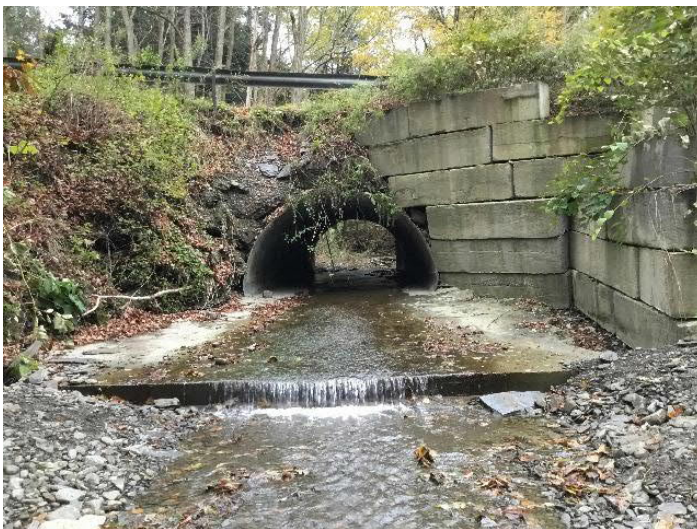
Allen Glen Road over Huntington Creek. Structure outlet. Note unstable wingwall and concrete-lined streambed, eroding road embankment, and outlet drop.

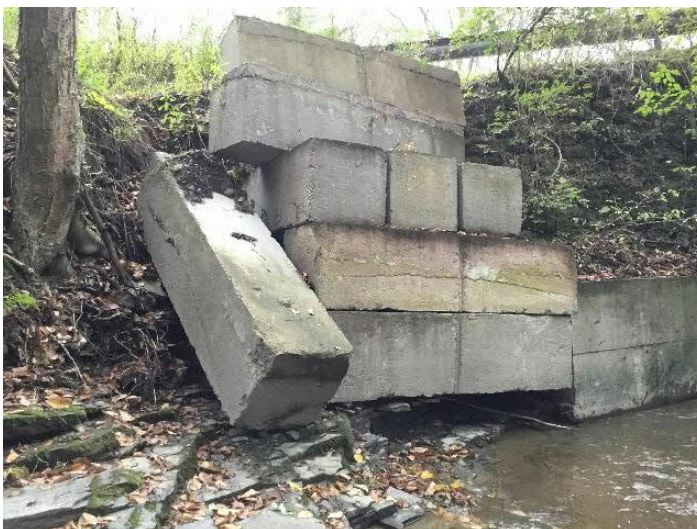
Allen Glen Road over Huntington Creek. Severely unstable wingwall upstream of structure inlet.

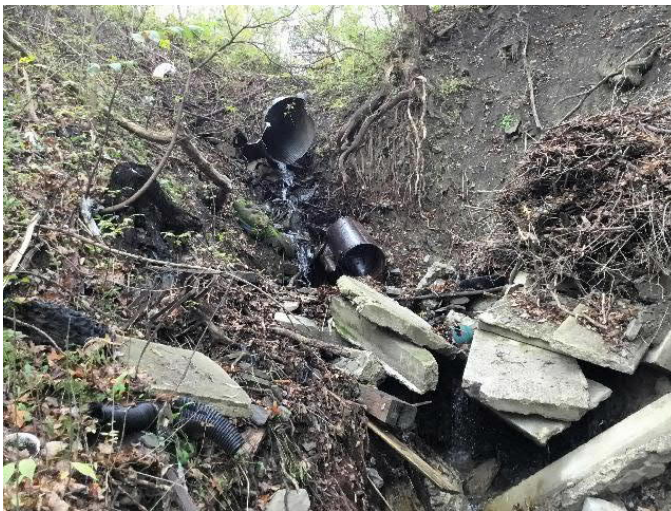
- The structure is in extremely poor condition, is somewhat undersized hydraulically, and constricts the stream from a geomorphic perspective based on its width relative to bankfull width. Sections of the outlet have broken off as erosion proceeds upstream.
- Continued failure of the structure and erosion of the streambanks threatens Carmichael Road.
- Continued mass failure of the streambanks downstream of the structure will continue to release sediment into the stream.

Carmichael Road over Tributary to Huntington Creek. Structure outlet, showing severe erosion and collapse of outlet section.

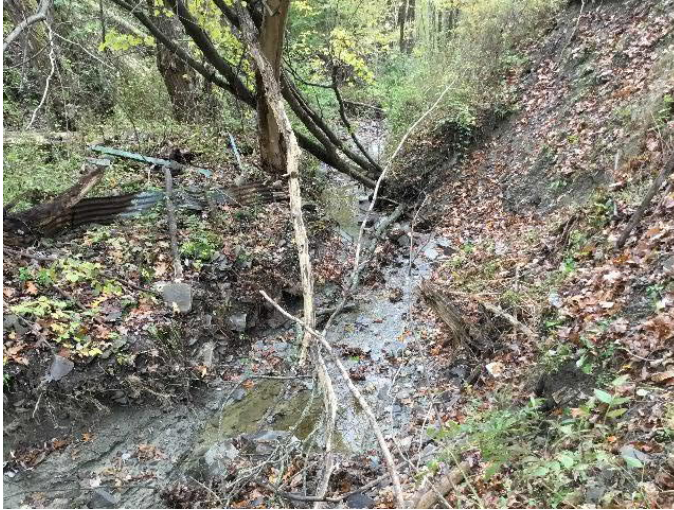
Carmichael Road over Tributary to Huntington Creek. Photograph of downstream channel. Note mass failure of slope on right bank.

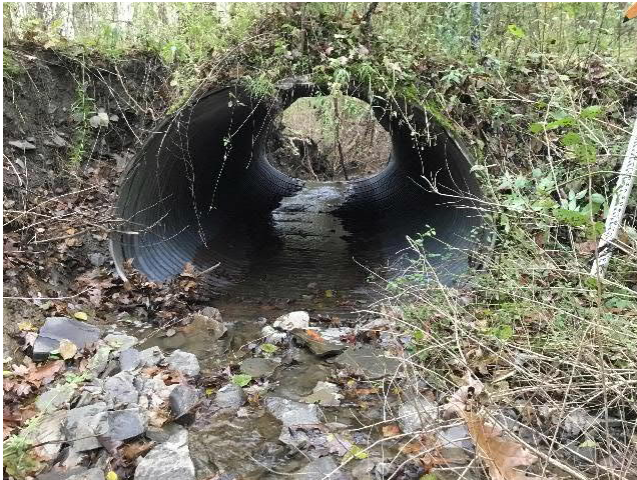
Private Driveway/Access Road off Carmichael Road over Tributary to Huntington Creek. Structure inlet. Note erosion on left side of structure.

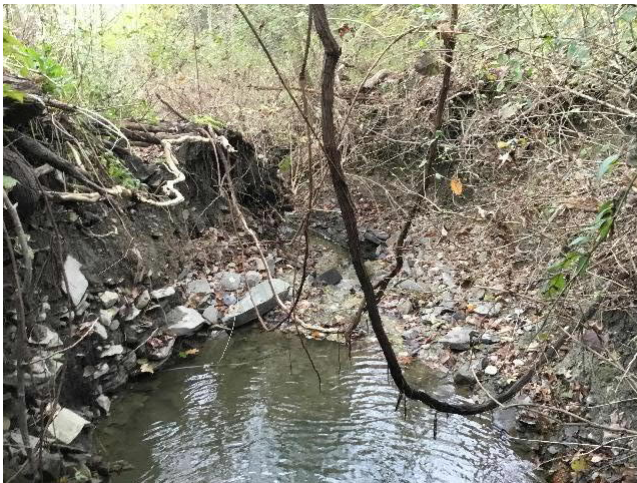
Private Driveway/Access Road off Carmichael Road over Tributary to Huntington Creek. Severely incised/eroded channel downstream of structure.
